6-7 Dicembre 2018, VI Giornata di Formazione

IL RUOLO DELLA CONOSCENZA NELLE VALUTAZIONI DI SICUREZZA STRUTTURALE DEL PATRIMONIO ARCHITETTONICO

Prof. Ing. Claudio Modena

TRA GEOLOGIA E GEOFISICA - XV WORKSHOP DI GEOFISICA
IL RUOLO DELLA CONOSCENZA NELLE VALUTAZIONI DI
SICUREZZA STRUTTURALE DEL PATRIMONIO ARCHITETTONICO

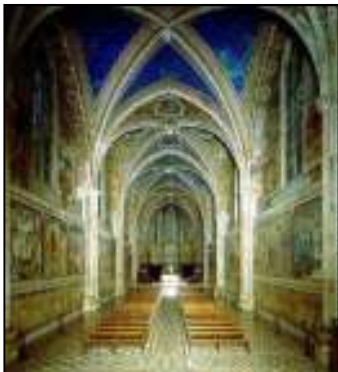
Sequence of the collapse of the vault of the Assisi Basilica during the 1997 earthquake

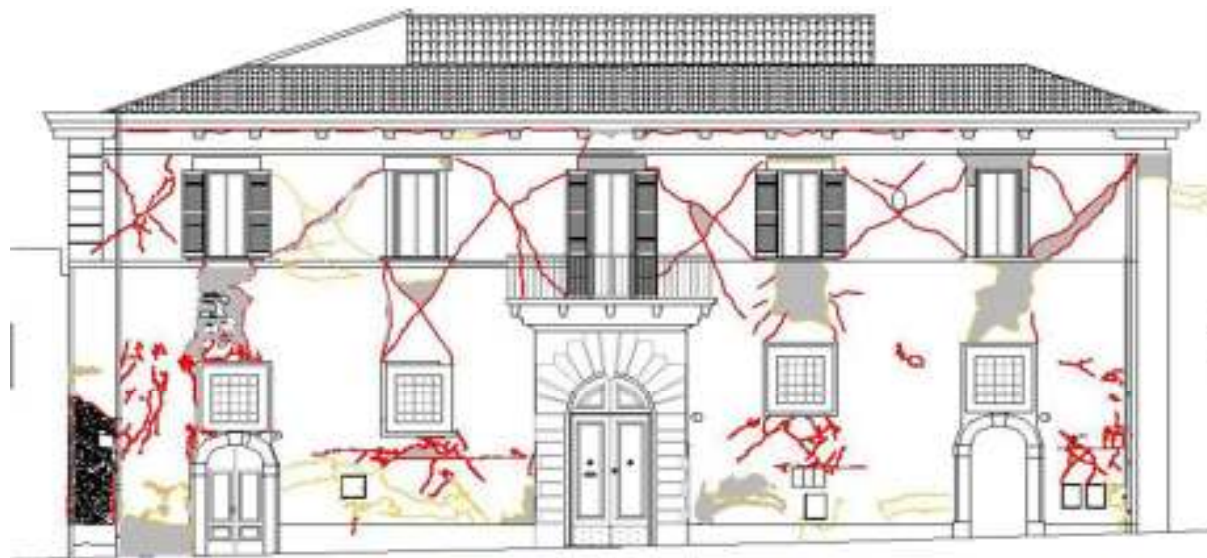
Survey and representation of eventual crack and deformation pattern.

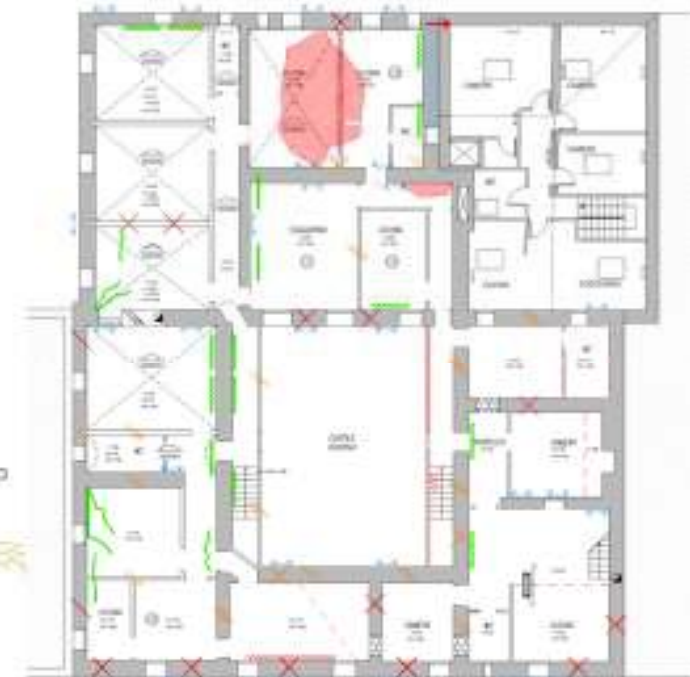
| lesione passante | distacco dell'intonaco |
| lesione non passante | intonaco armato pre-esistente |

SPANCIAMENTO	INCROGIO
CROLLO	MARTELLO
LESIONE NON PASSANTE	LESIONE AL CANTONALE
LESIONE PASSANTE	FESSURE SU PAVIMENTO
LESIONE DIFFUSA	FESSURE SU SOLAIO
LESIONE A CROCE	TIRANTI

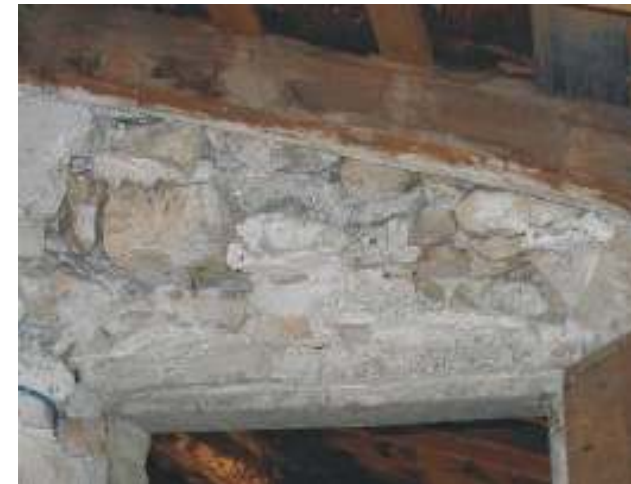
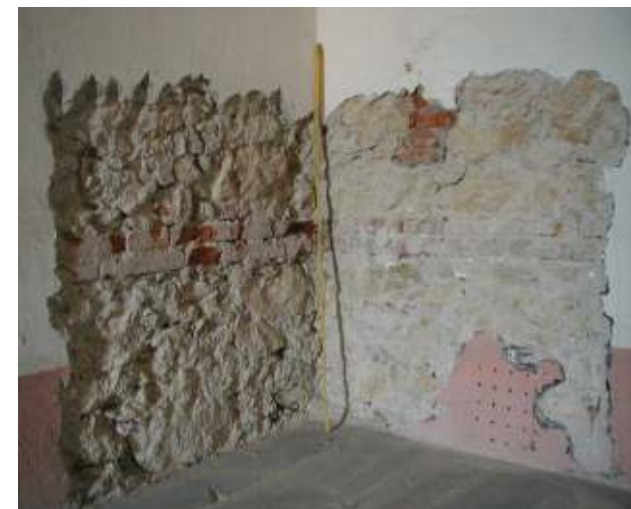
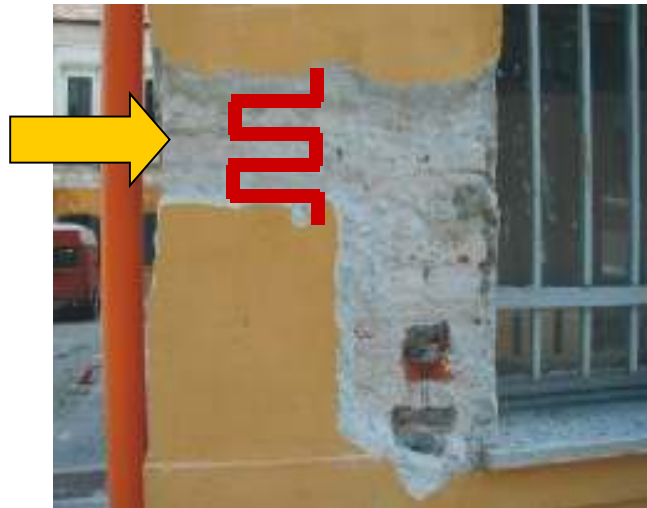
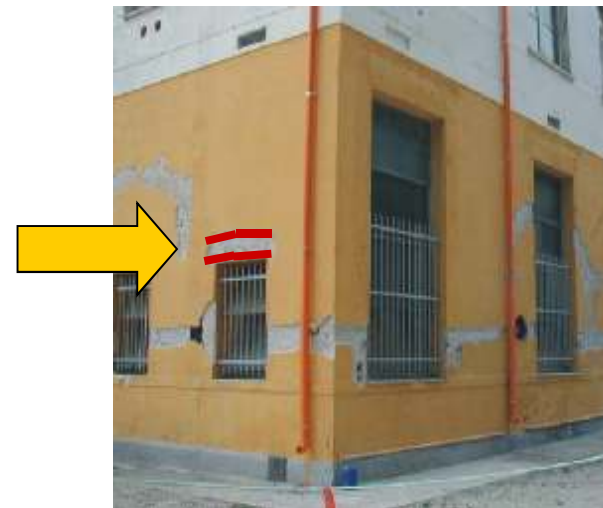
CONSTRUCTION DETAILS

- a) quality of **connections** between walls;
- b) type and quality of **connections** between horizontal diaphragms and walls;
- c) type and efficiency of **lintels** above openings;
- d) presence and efficiency of elements to counteract **horizontal trusts**;
- e) Presence of structural or non structural elements with high vulnerability;
- f) type of **masonry**

This critical analysis is carried out by means of visual inspections, by removing plaster and small masonry dismantling, in order to check both masonry texture and masonry in its thickness, considering also the connections between walls and between walls and floors.

Limited on-site verifications: based on visual surveys, usually through tests on the masonry that lead to superficial examination

Extended and comprehensive on-site verifications: based on visual surveys, usually through tests on the masonry that lead to both superficial and deep examination, and of the connection between orthogonal walls.

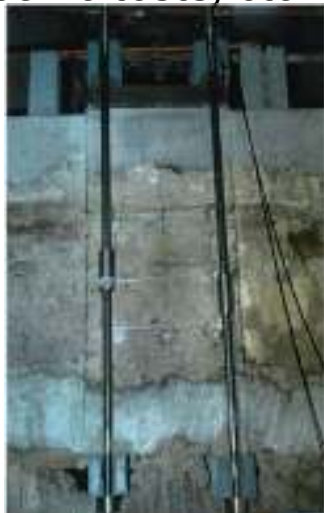
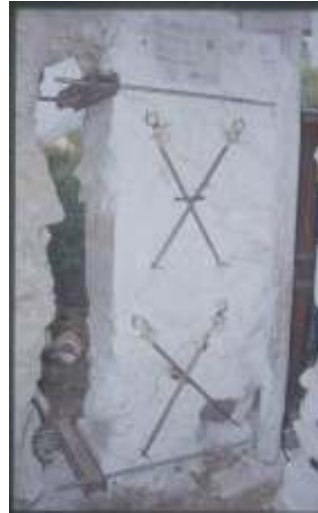
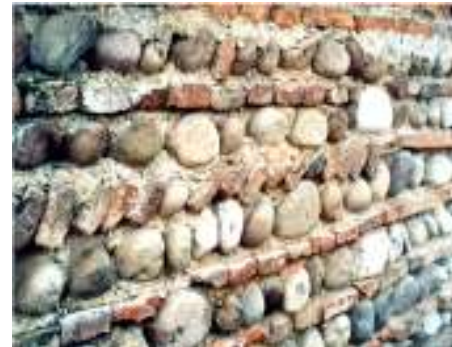
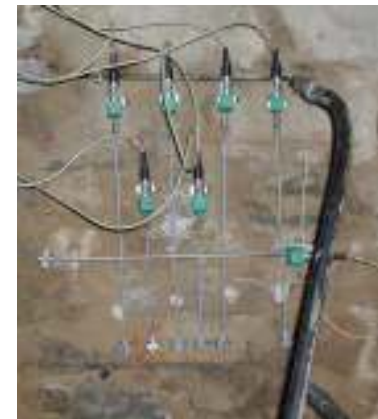
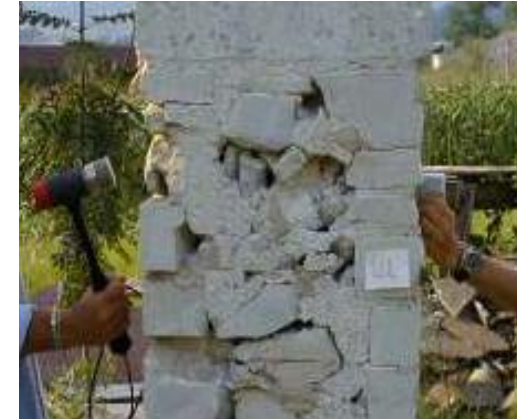
Extended on-site investigations:

Tests with double flat jack and characterization tests of the mortar and of stones or bricks. Non-destructive tests (sonic tests, etc...).

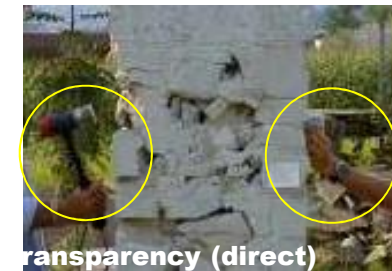
Sonic pulse velocity test

The use of sonic tests has the following aims:

- to qualify masonry through the morphology of the wall section;
- to detect the presence of voids and flaws;
- to find crack and damage patterns;
- to control the effectiveness of repair by injection technique.

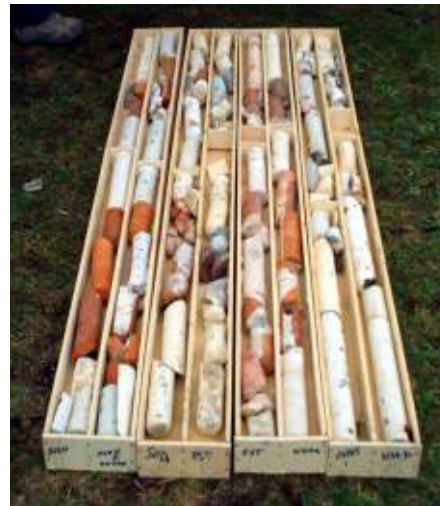
Overlapping: sonic tomography – core samples

Examples of sonic tomography and coring (Example of San Zeno bell tower)

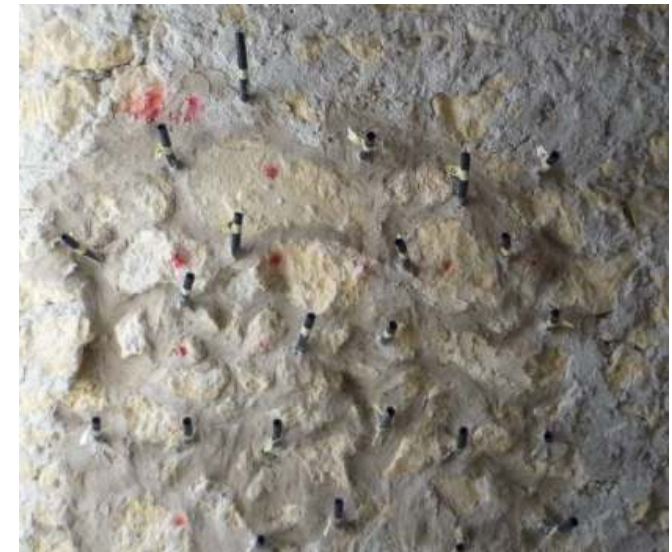
The **sonic tests** are adopted in situation pre and post injection in order to evaluate their efficacy analysing:

- Average increment of velocity
- Distribution of the injection in the investigated area

Examples of sonic (Control of injection)

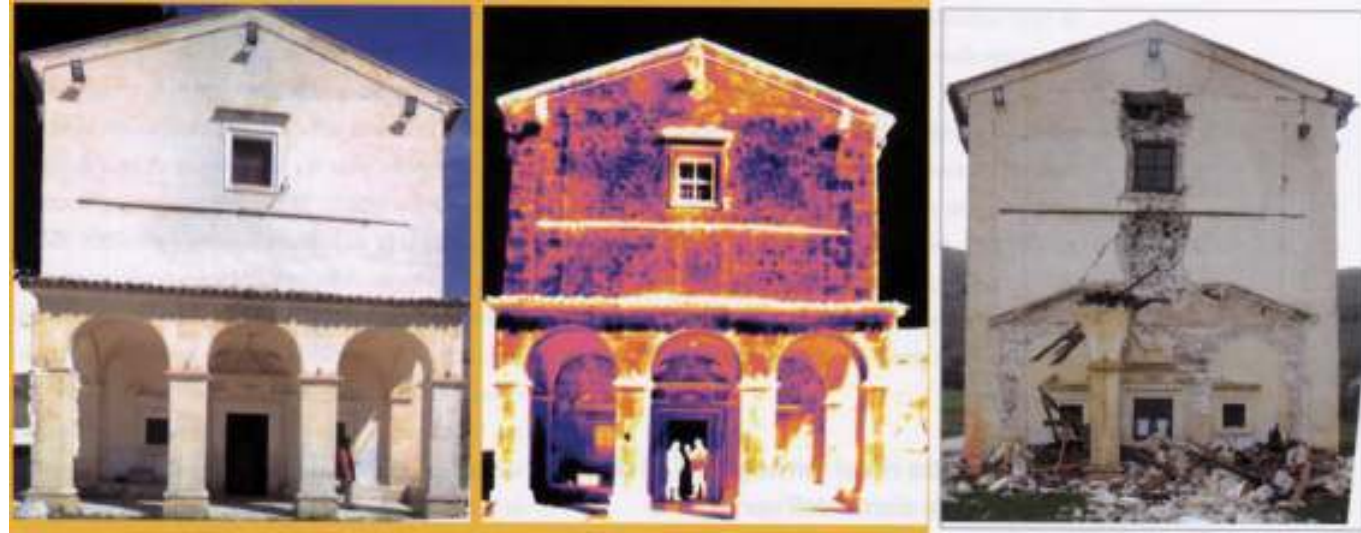
Comparison between IR termography and damages occurred on the façade of S. Stefano's church [Grinzato 2009]

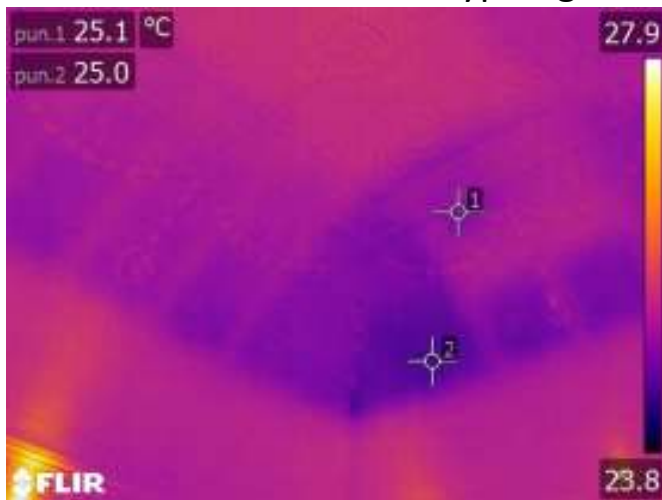
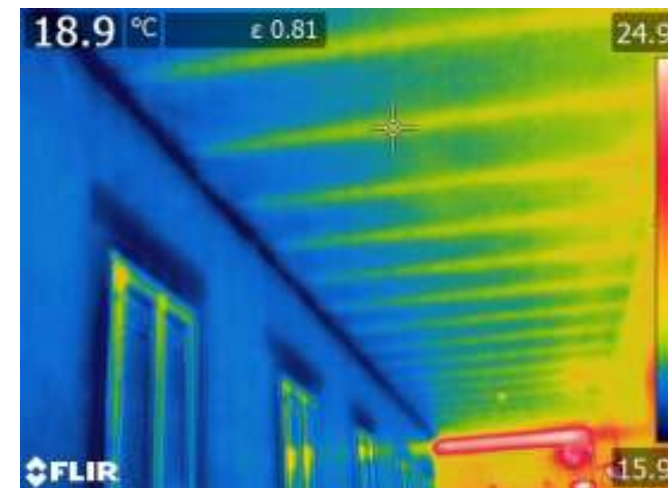
Identification of material and typologies: ceilings (wattle, L) and roofs (concrete, R)

Thermographic analysis

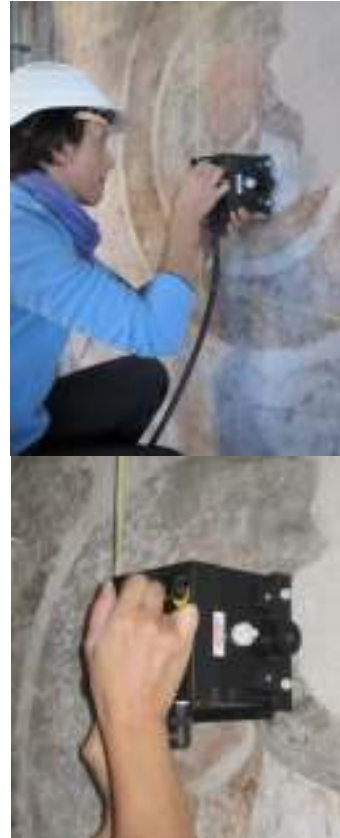
Non destructive tests (NDT): Georadar

When applied to masonry, the applications of radar procedures can be the following:

- to locate the position of large voids and inclusions of different materials, like steel, wood, etc.;
- to qualify the state of conservation or damage of the walls;
- to define the presence and the level of moisture;
- to detect the morphology of the wall section in multiple leaf masonry.

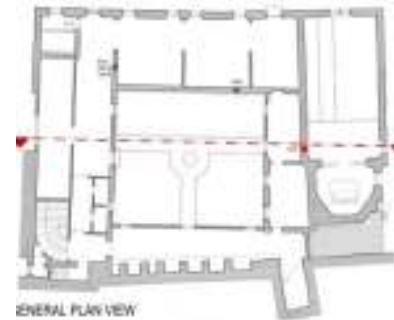
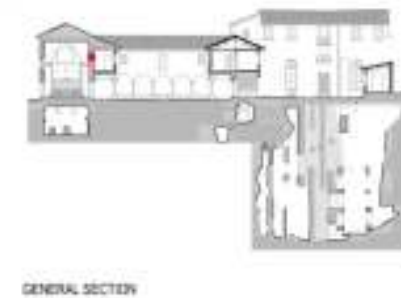
Comparison between Georadar and Sonic test

- Comparison among different NDT techniques
- GPR and Sonic demonstrates to be more reliable
- Confirmation of anomalies detecting during restoration and by both methodologies

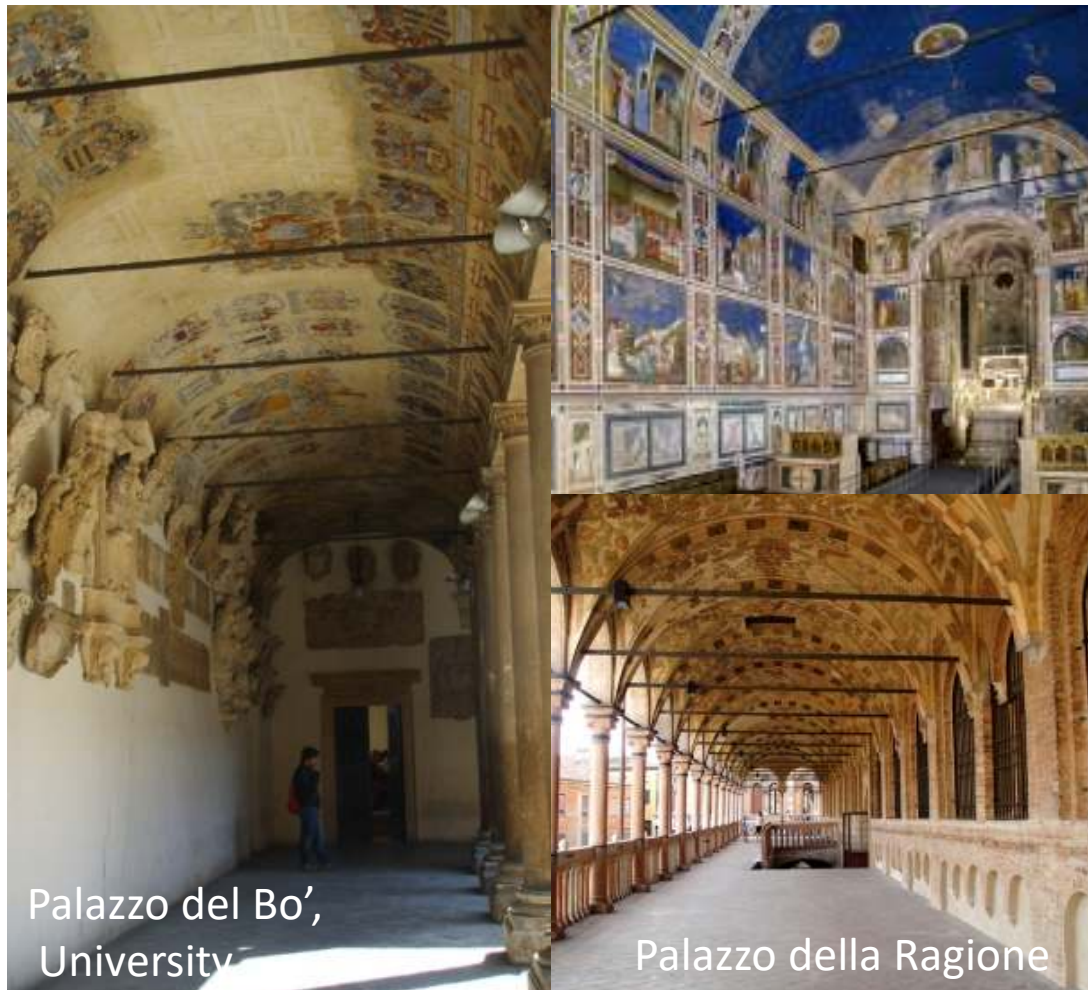
ANALYSIS OF AXIAL STRESS IN TIES

Palazzo del Bo',
University

Palazzo della Ragione

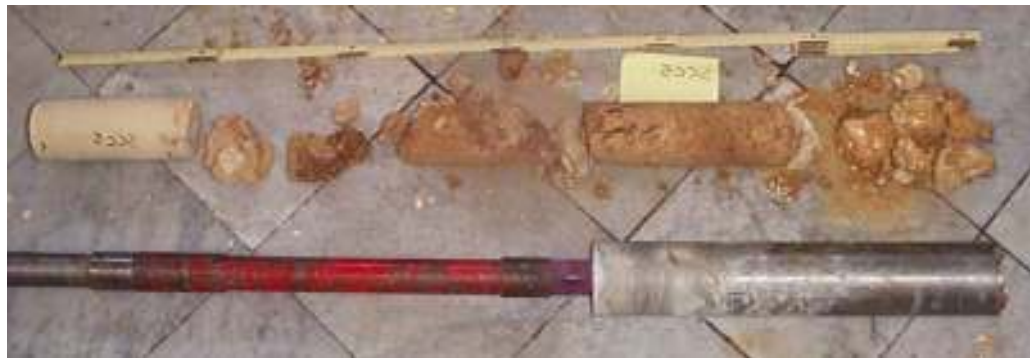
Coring should be done with a rotary driller using a diamond cutting edge.

A small camera may be inserted into the borehole allowing a detailed study of its surface and try a reconstruction of the wall section.

Drilled core and reconstruction (Binda, 2000)

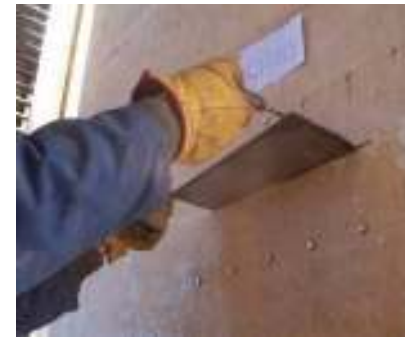
The determination of the **state of stress** is based on the stress relaxation caused by a cut perpendicular to the wall surface; the stress release is determined by a partial closing of the cutting, i.e. the distance after the cutting is lower than before. A thin **flat-jack** is placed inside the cut and the pressure is gradually increased to obtain the distance measured before the cut.

Single flat-jack test (detection of state of stress) carried out at the Monza Tower (Binda, 1998)

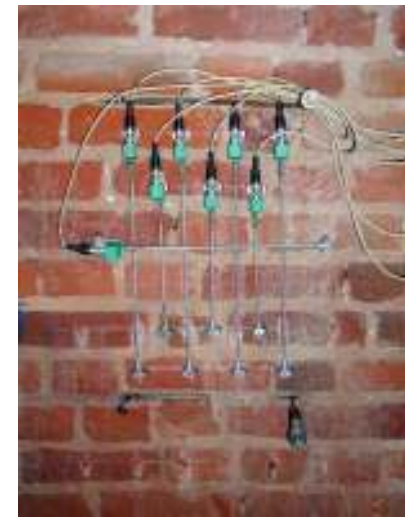
Double flat-jack test (stress-strain behaviour) on West side of the Monza Tower (Binda, 1998)

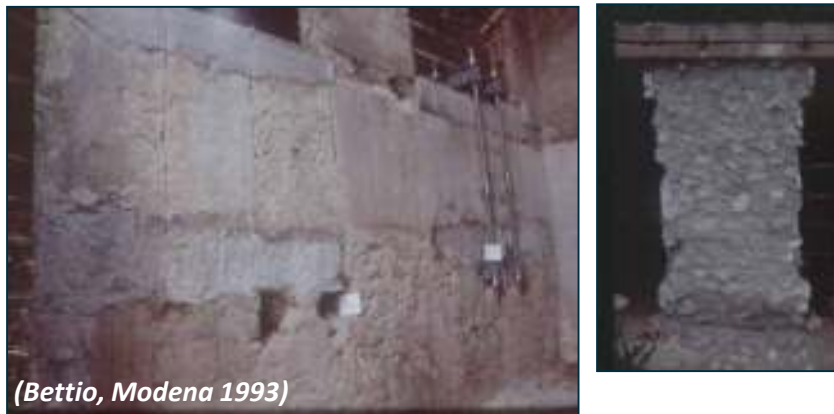
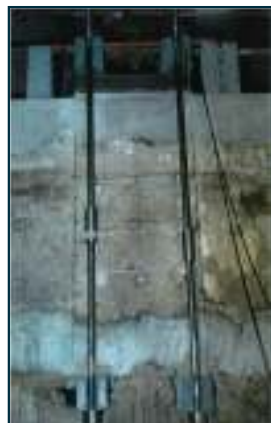
Destructive tests (DT) realised before and after strengthening intervention

Mechanical characteristics for vertical actions

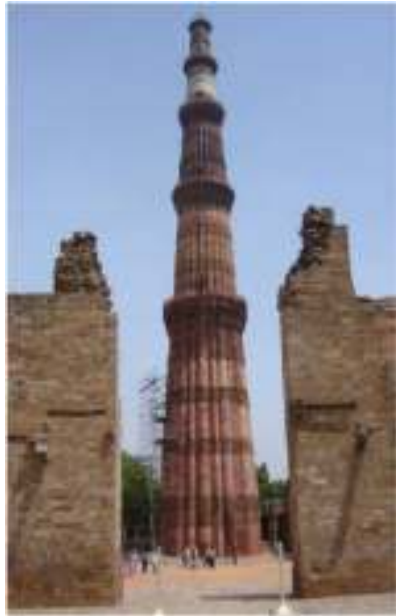
Qutb Minar – New Delhi (India)

- Positioning of sensors:
 - 1 - acceleration transducers
 - 2 - temperature and R.H. sensor
 - 3 - displacement transducer
 - 4 - wind velocity and direction transducer
- Data acquisition and analysis

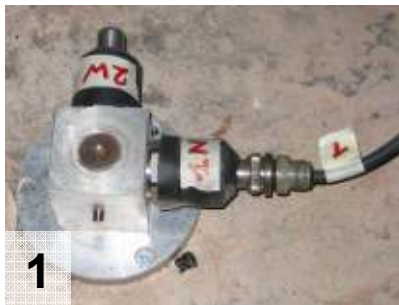
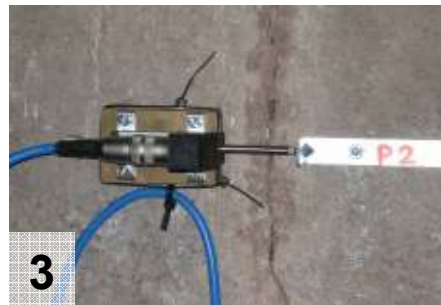
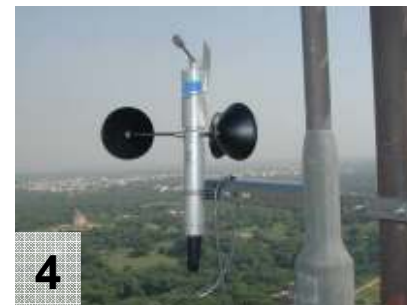
Example of a dynamic monitoring system: Qutb Minar – New Delhi (India)

- ACCELERATION TRANSDUCERS
- ANEMOMETER
- DISPLACEMENT TRANSDUCERS
- TEMPERATURE AND RH SENSORS

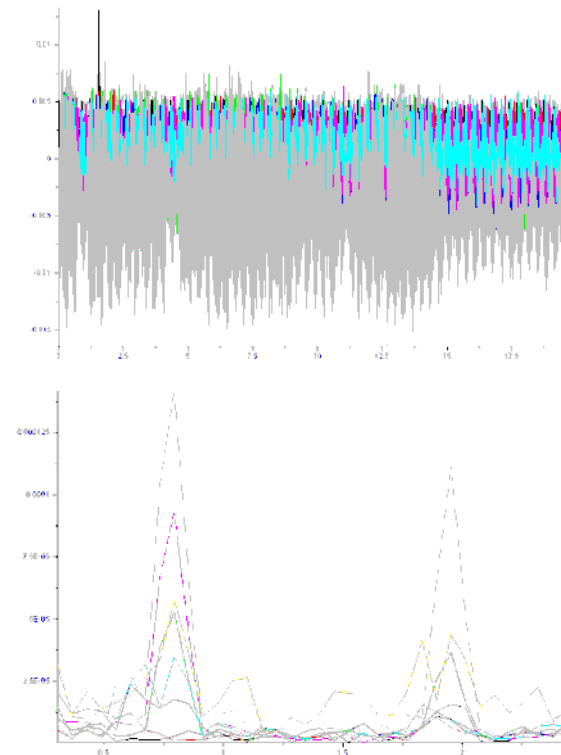
- time history recorded by the monitoring system – 09:29:20, 8th Oct /2005 CPU time
- **Fourier transform**
- positioning of the accelerometers in the Qutub Minar

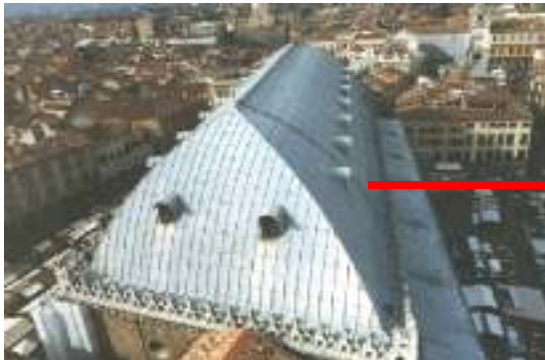
Palazzo della Ragione (Padua, XIII-XV c.)

- wind effects monitoring
- stepped sine test
- FE modeling
- modal identification
- www data management

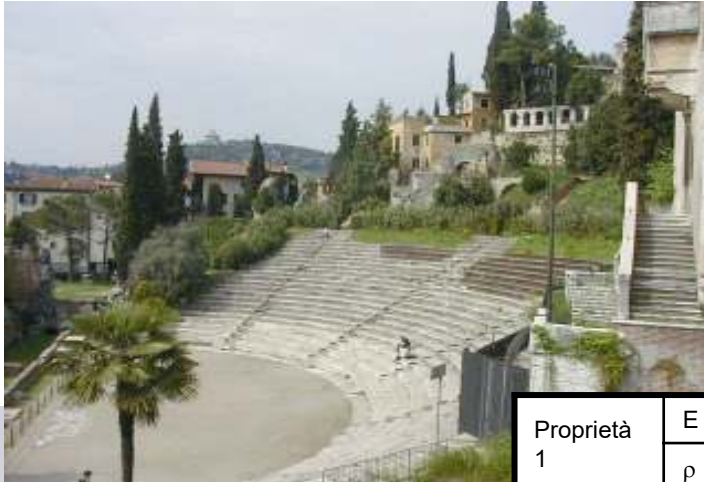
Roman Theatre (Verona)

- shock test
- stepped sine test
- modal identification

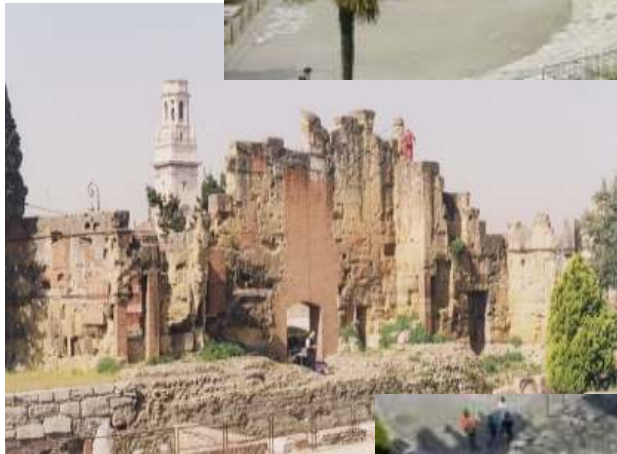
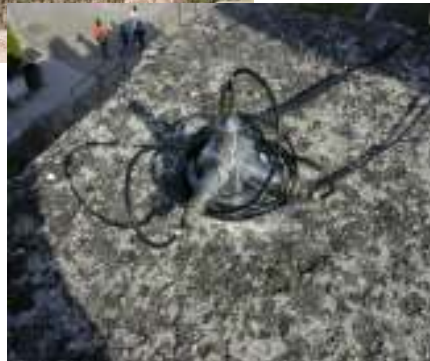
Proprietà 1	E	1.2E+03	MPa
	ρ	1.3E+03	kg/m ³
Proprietà 2	E	3.2E+03	MPa
	ρ	1.3E+03	kg/m ³
Proprietà 3	E	1.2E+03	MPa
	ρ	1.5E+03	kg/m ³

Scene
 $f_1=3.44$ Hz

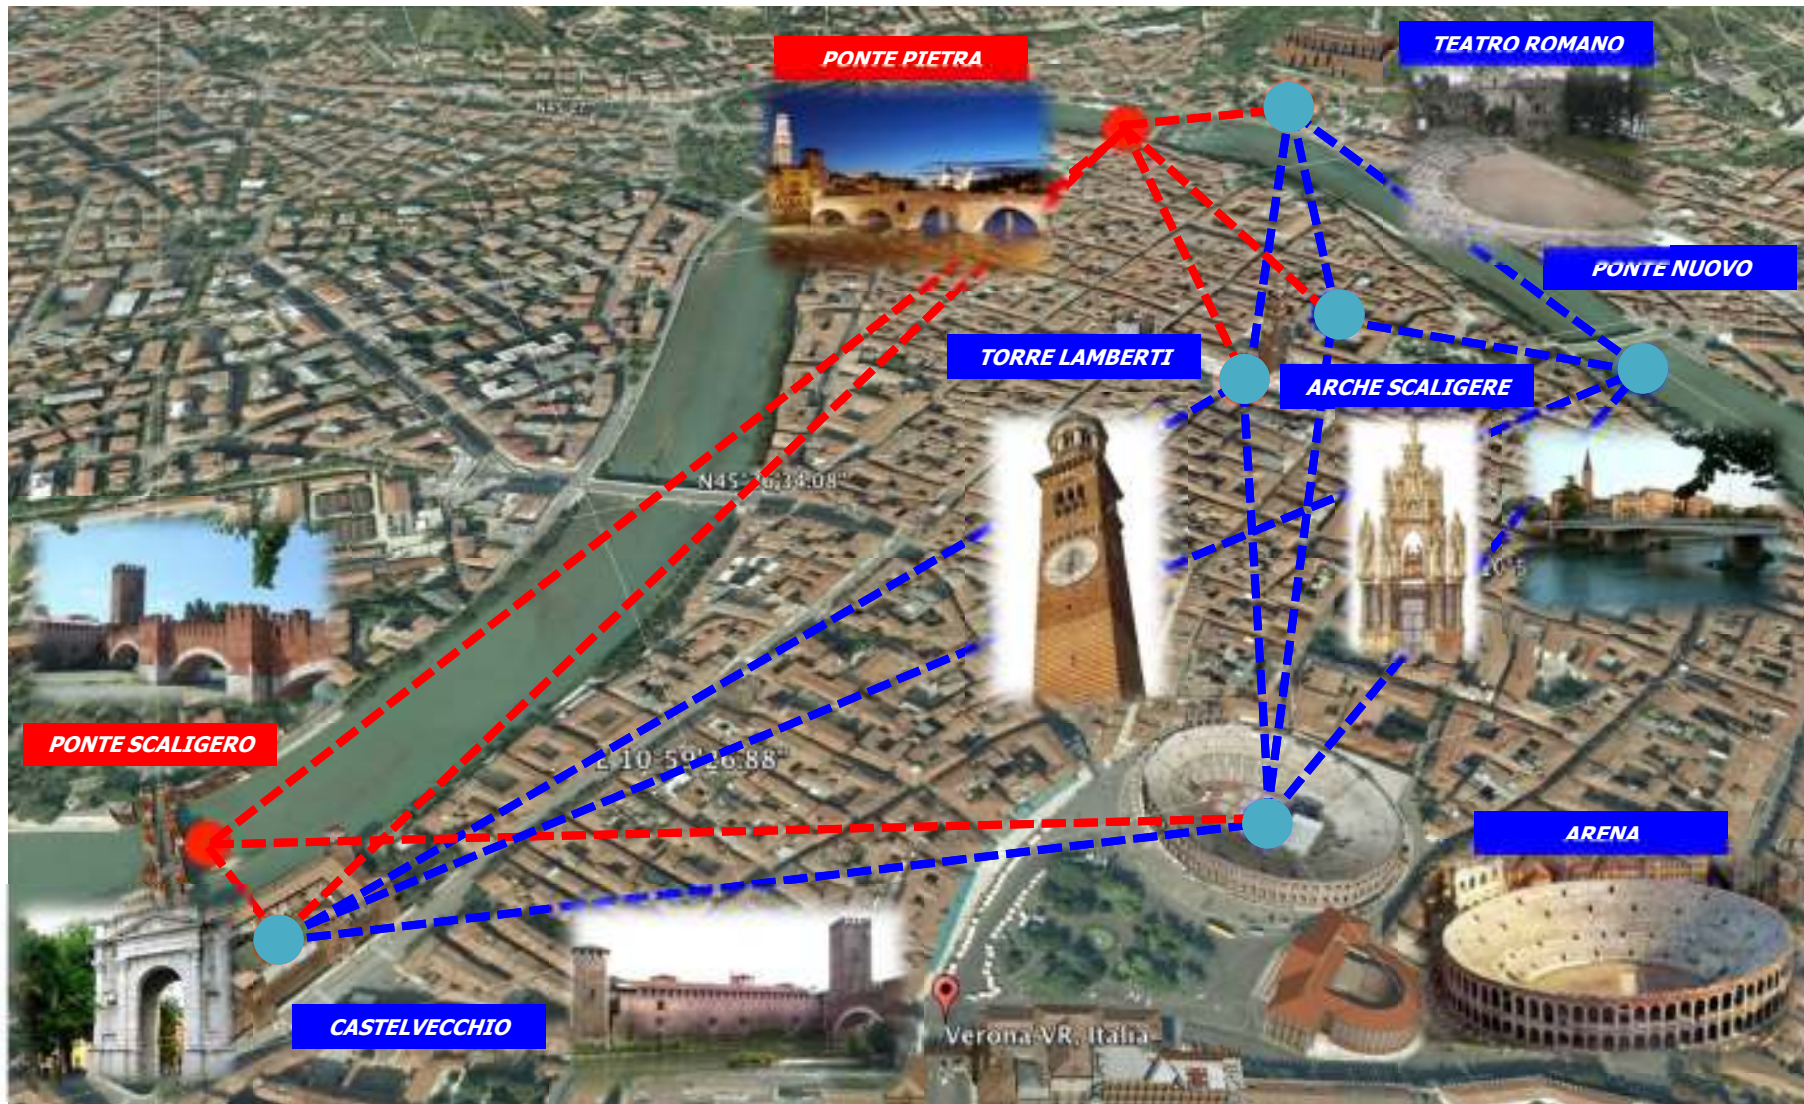
SHM NETWORK: CANSIGNORIO STONE TOMB

4 SINGLE-AXIS ACCELEROMETERS

1 TEMPERATURE/RH

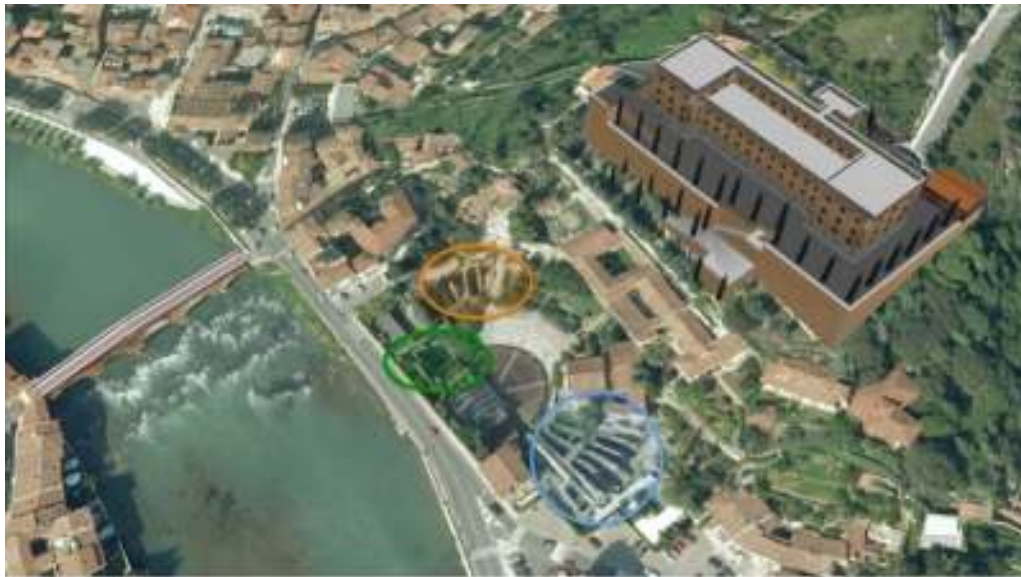
SHM NETWORK: ROMAN THEATER

3 SISTEMI INDIPENDENTI

Unità acquisizione 1
 Accelerometri 4
 Potenzimetri 4
 Temperatura/Umidità 1
 Inclinatorio 1

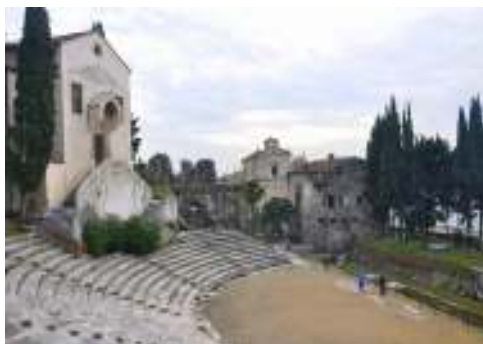
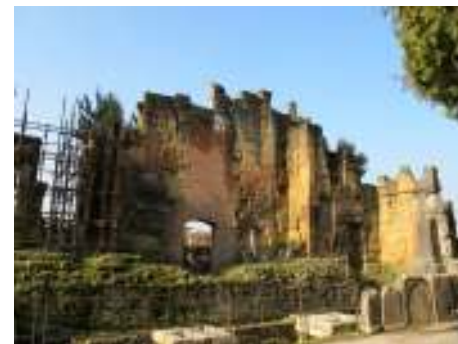
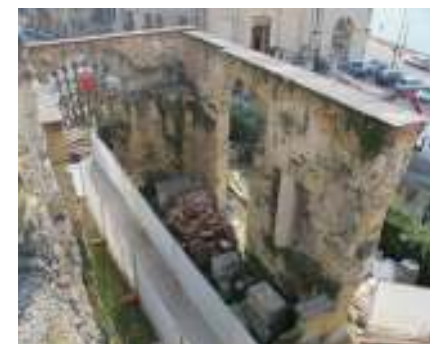
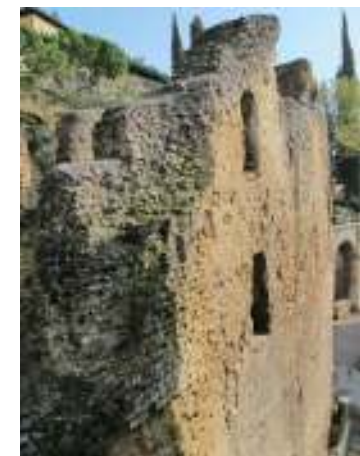
SHM NETWORK: CASTELVECCHIO

- 6 DISPLACEMENT TRANSDUCERS
- 1 TEMPERATURE/RELATIVE HUMIDITY SENSOR
- 6 ACCELEROMETERS
- 1 MASTER
- 1 WIRELESS SENSORS NODE

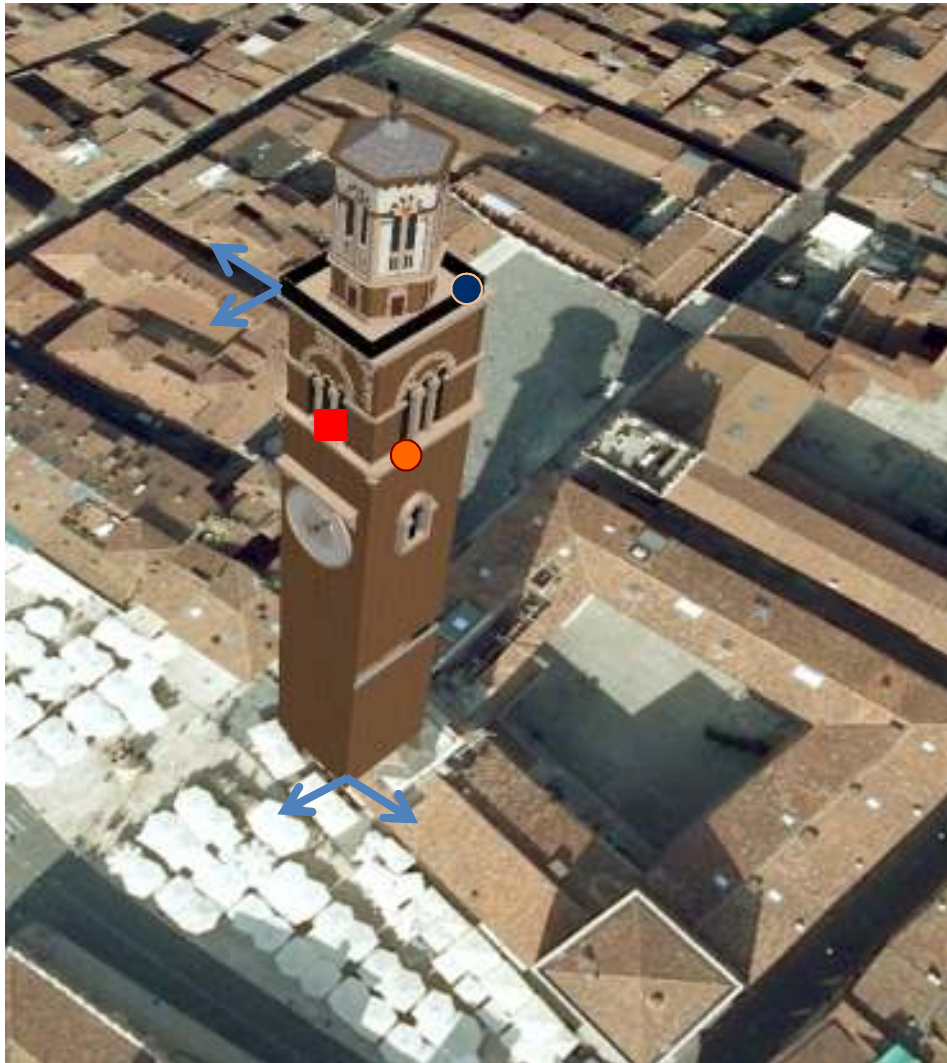
SHM NETWORK: LAMBERTI TOWER

- 1 ANEMOMETER
- 1 TEMPERATURE/RELATIVE HUMIDITY SENSOR
- 4 ACCELEROMETERS
- 1 MASTER

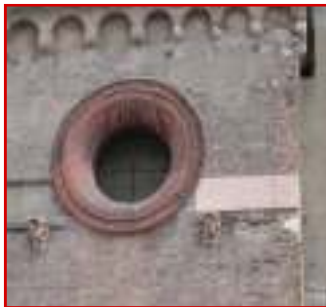
The façade presents towards the church square a rough and heterogeneous external aspect.

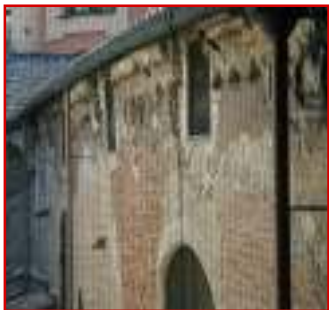
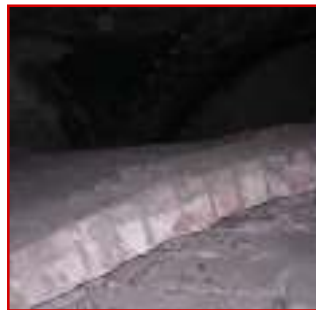
The masonry walls of the clerestory present a strongly composite aspect, being subject to past interventions comporting remarkable size windows closing.

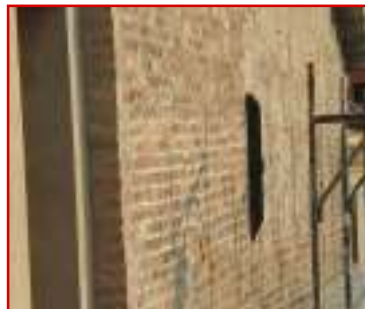
The Cathedral is generally provided with connective systems (metallic tie-beams), present in the central nave and in the aisles, in the arches connecting the dome sustaining pillars, in the transept, in the apses, in the dome lantern and in façade.

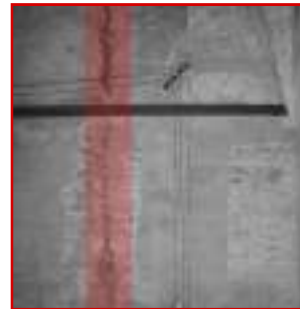
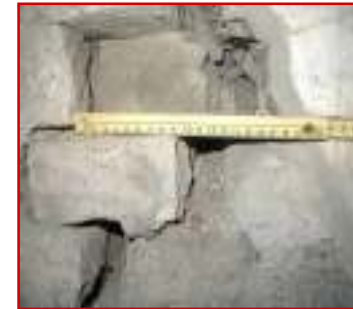
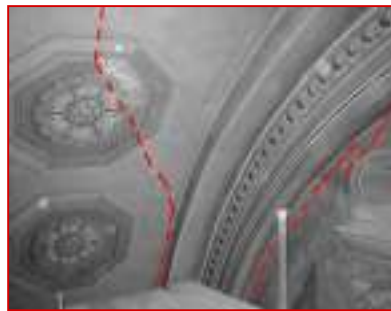
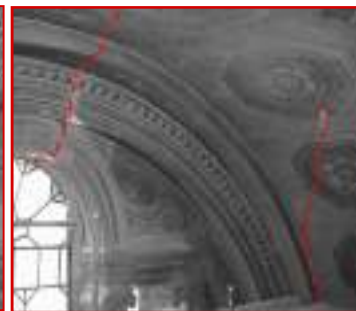
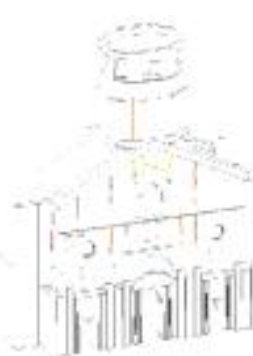
Façade

The present damage pattern shown by the Cathedral is highly indicative of the structural response of the building, and denounces the areas manifesting higher seismic vulnerability.

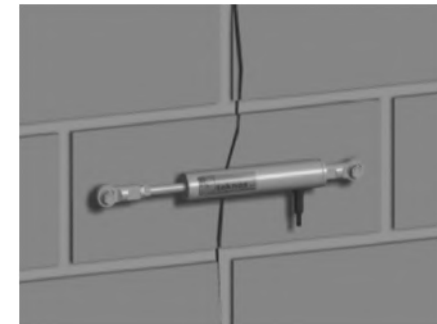
Multi-base extensometer

Electrical extensometer

- ❑ relative displacements between the vertical structures;
- ❑ eventual variations in the openings on the main cracks;
- ❑ settlements of the foundation soils below the crypt's two main pillars;
- ❑ air temperature control.

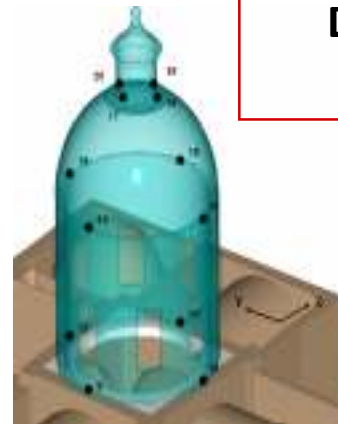
Sonic testing

dome

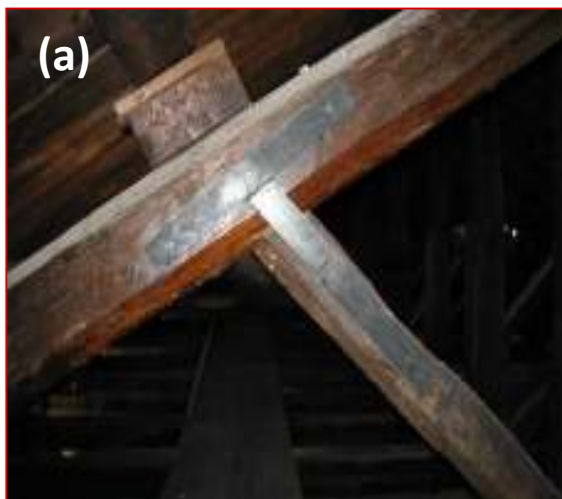
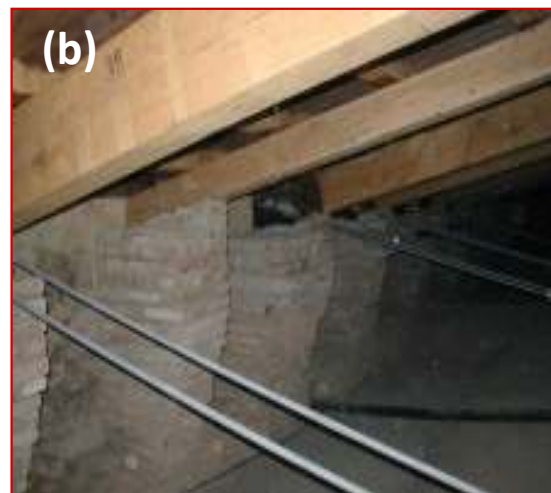
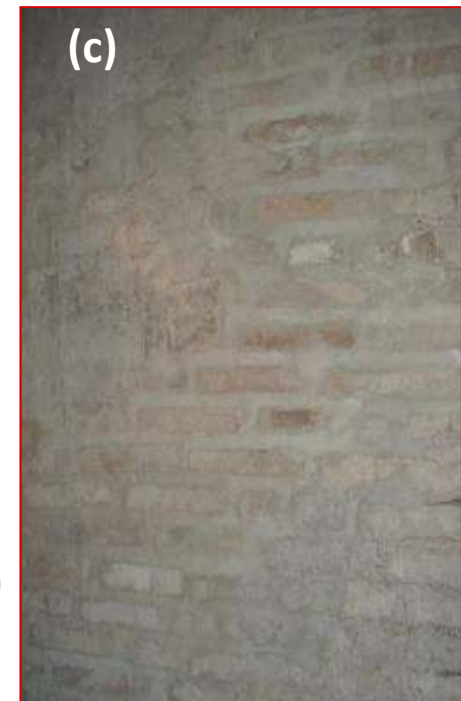
Roof wooden trusses: (a) metallic “T” shaped connection elements; (b) substitution of the old wooden trusses of the left nave with new elements, with stainless steel tie beams. Roof level: (c) a “scuci-cuci” intervention.

General interventions were carried out by using traditional techniques, devoted to give back to the structure its integrity and continuity, to reestablish connections between structural elements and to substitute damaged structural elements. The typology of these interventions are:

- ❑ the traditional “scuci-cuci” (substitution of damaged elements with new ones);
- ❑ mortar repointing and grout injections, especially in the cracked vaulted system.

- ❑ restoration of the wooden truss structure;
- ❑ reestablishment of the connections between wooden structural elements.

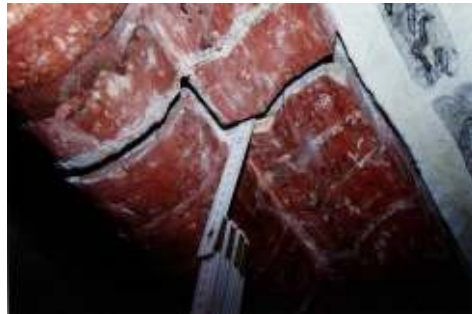
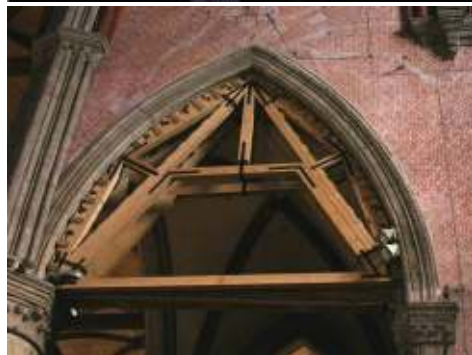
Experimental investigations and monitoring

- 1990**
- fotogrammetric survey;
 - geotechnical investigations on the foundation's soil;
 - endoscopies;
 - single and double flat-jack tests on the masonry elevation structures;
 - sonic tests on steel ties;
 - monitoring of the main cracks, by means of extensometers;
 - positioning of clinometers (detection of rotations of the bell-tower).

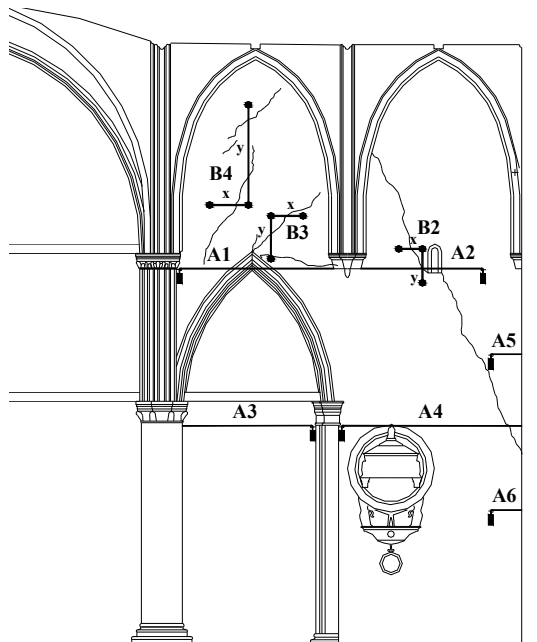
A : long-base extensometers
B : crack-gauges

- **6 long base extensometers** relative displacements between the walls of the bell-tower and the adjacent structures of the basilica;
- **8 crack-gauges** installed on the main cracks of the South-West side of the bell-tower and of the wall above the stone arch.

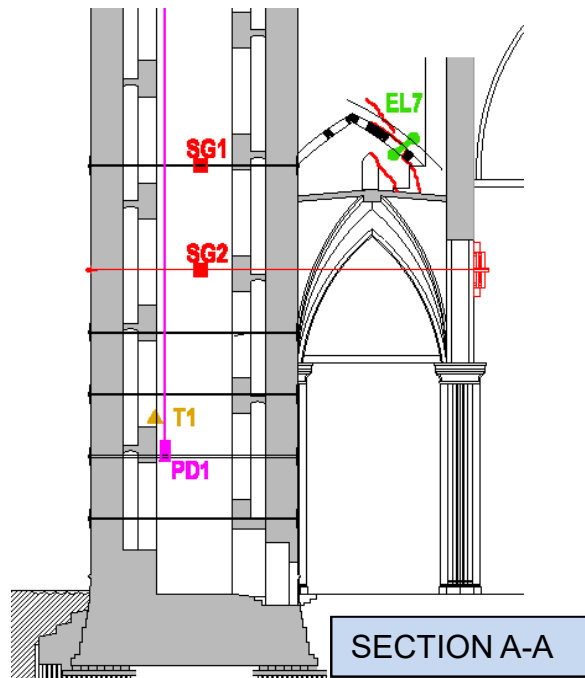
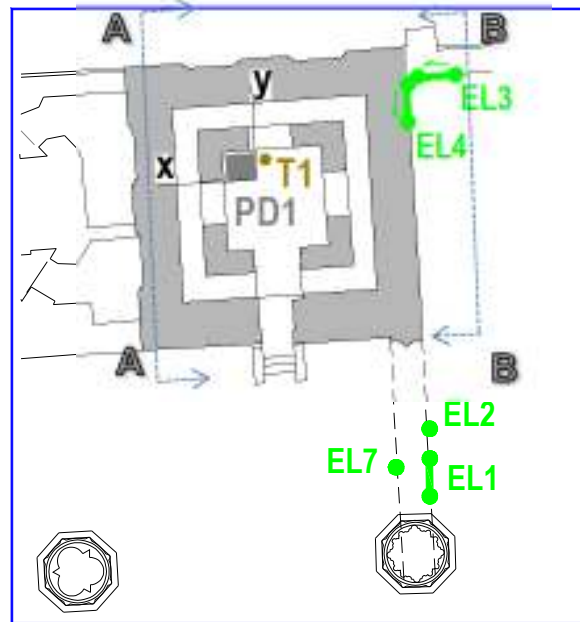
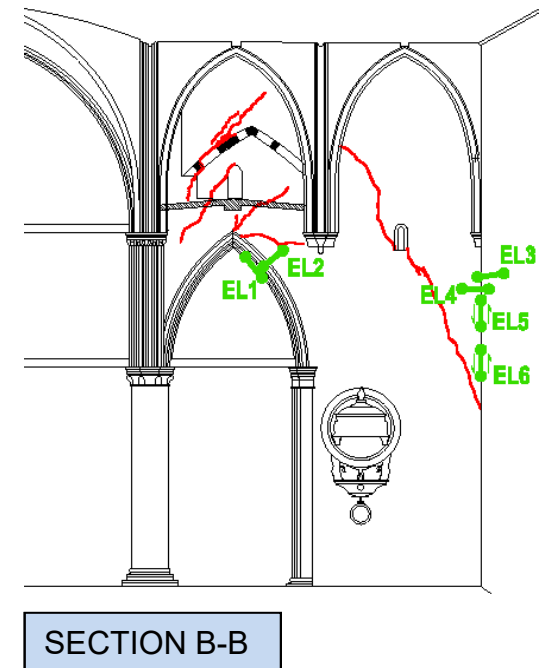
- Direct Pendulum
- Crack-gauges
- Strain Gauges
- Temperature sensors

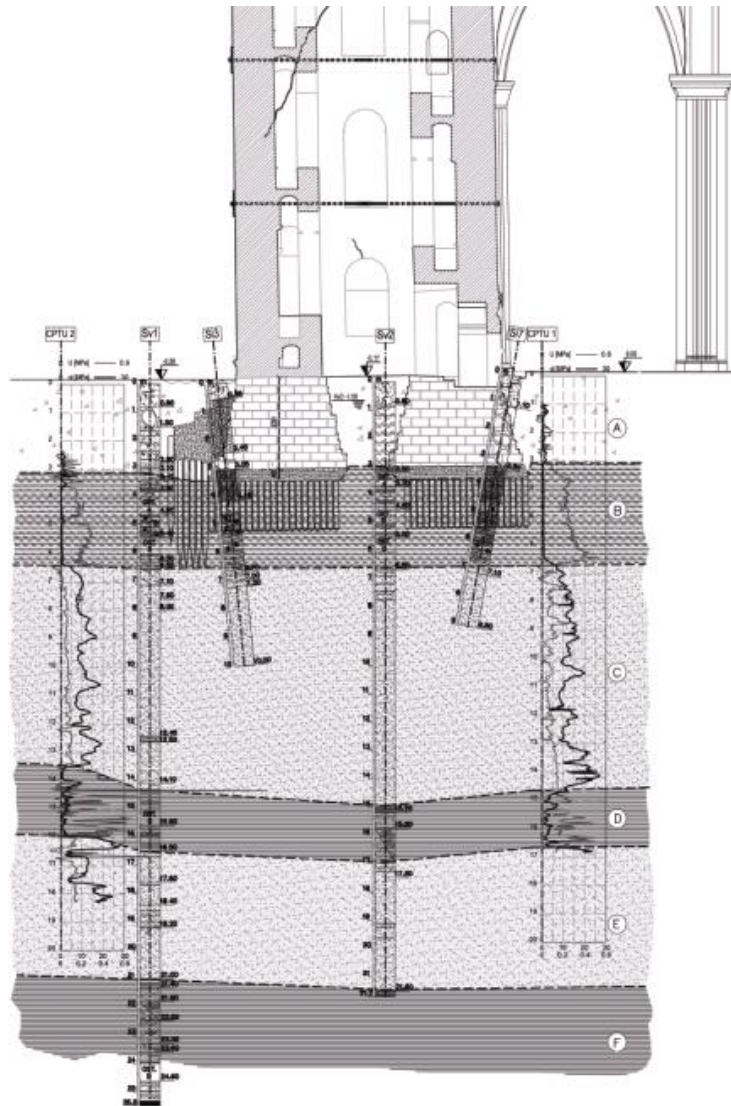
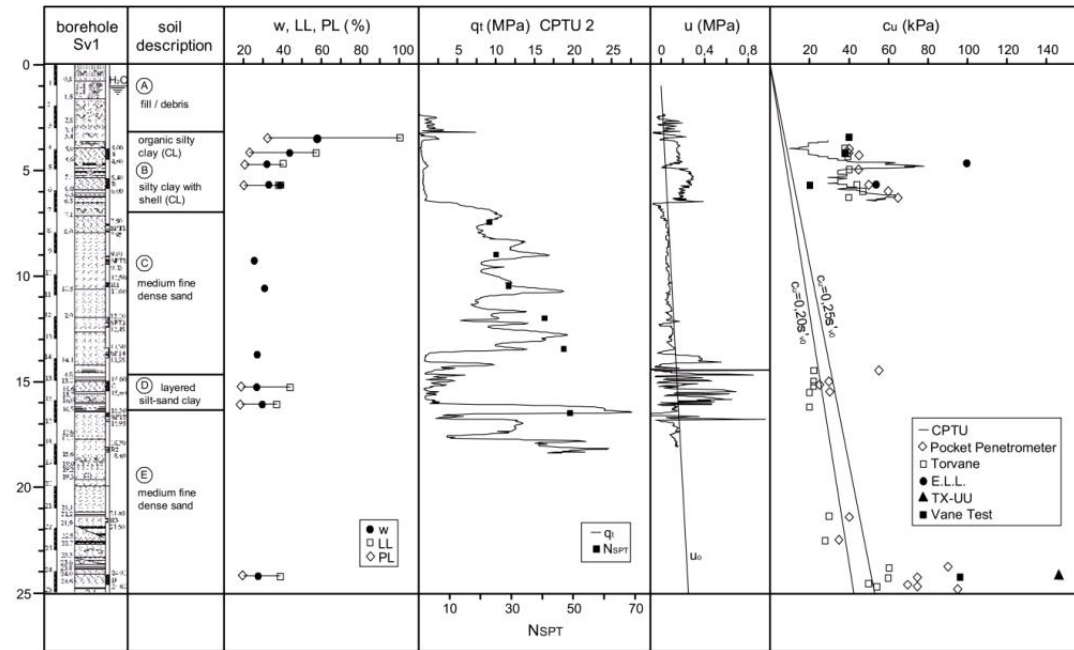
Geotechnical section and foundation geometry

Some **progressive failure of the soft silty clay layer**, squeezed between the piles end and the unit C, must be taken into account.

In addition, a **possible increasing decay of the mechanical characteristics of the wooden piles** under the foundation block could also be seen as concomitant cause.

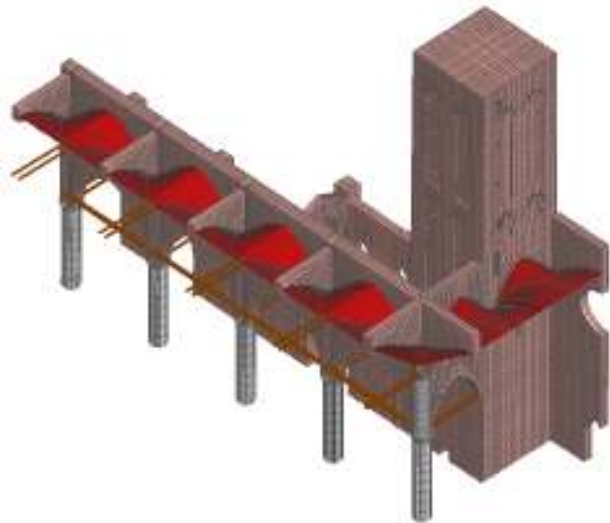
Structural modeling

The modelled portion of structure includes the **bell-tower and the adjoining parts of the church** that were mostly affected by the interaction with the tower

The only load condition considered is the **self weight**. The load corresponding to some parts of the real structure not modelled (timber structure roof of the basilica, belfry), was imposed as external forces; the crossed vaults' filling was included as surface load.
