6-7 Dicembre 2018, VI Giornata di Formazione

IL RUOLO DELLA CONOSCENZA NELLE VALUTAZIONI DI SICUREZZA STRUTTURALE DEL PATRIMONIO ARCHITETTONICO

Prof. Ing. Claudio Modena

TRA GEOLOGIA E GEOFISICA - XV WORKSHOP DI GEOFISICA
IL RUOLO DELLA CONOSCENZA NELLE VALUTAZIONI DI
SICUREZZA STRUTTURALE DEL PATRIMONIO ARCHITETTONICO

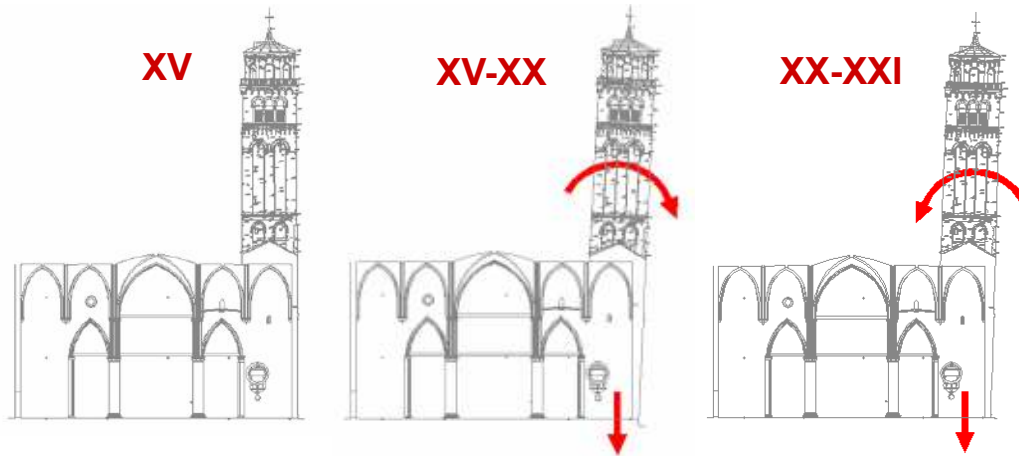
2002 model

- preferential channels of **compressive stress** localized inside the masonry wall above the propped arch;
- high **tensile stresses** found in the same masonry wall, due to the settlements of the bell-tower → wide crack patterns and loss of shape of the stone arch;
- **high stress** found below the capital of the column → horizontal thrust determined by the movements of the bell-tower;
- **tensile stress** in correspondence of the bell-tower window opening on the transept → presence of the main fissure on the external pipe of the bell-tower.

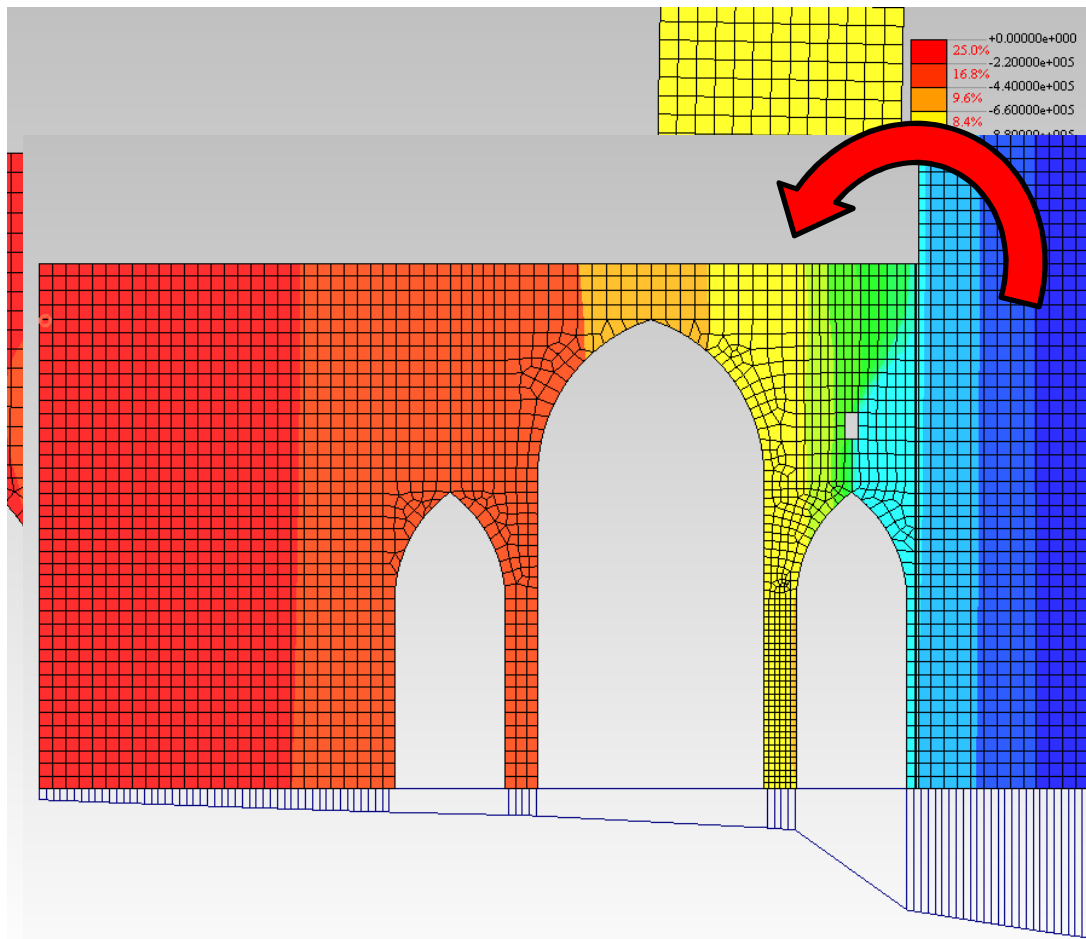
3RD PHASE: 1903-2008

Settlements during the 20th c.:
reversal of tower's rotation
toward the church after the
intervention on foundations

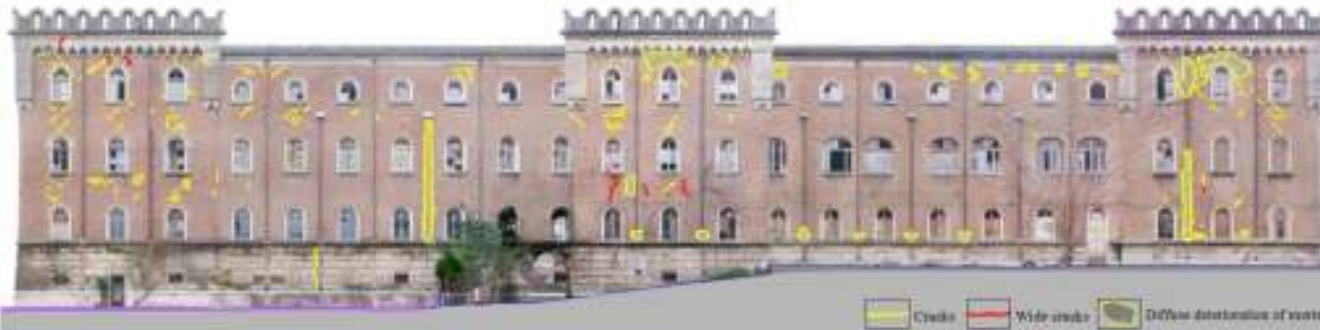
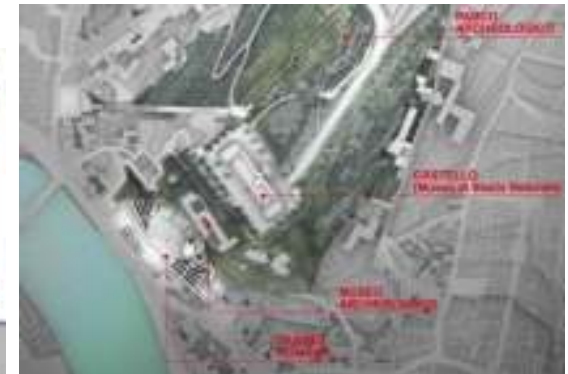
- Geometrical survey

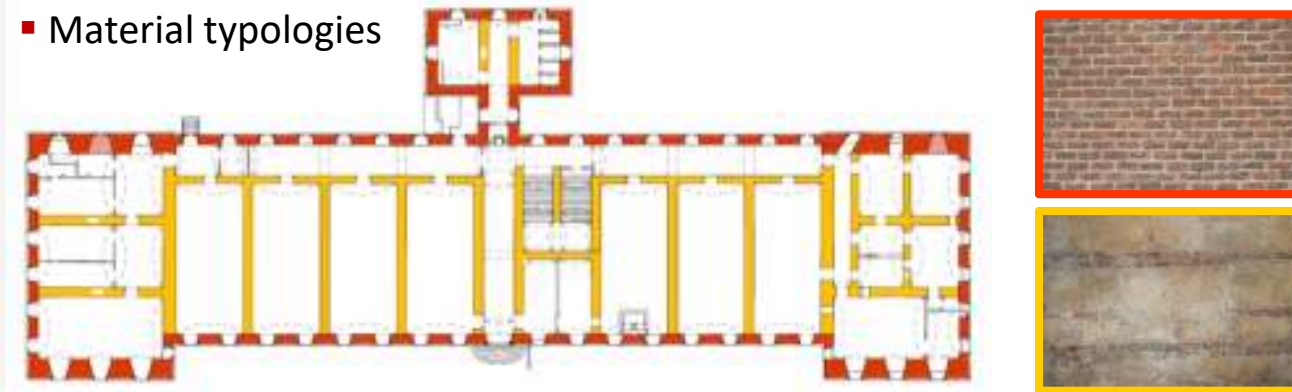
- Material typologies

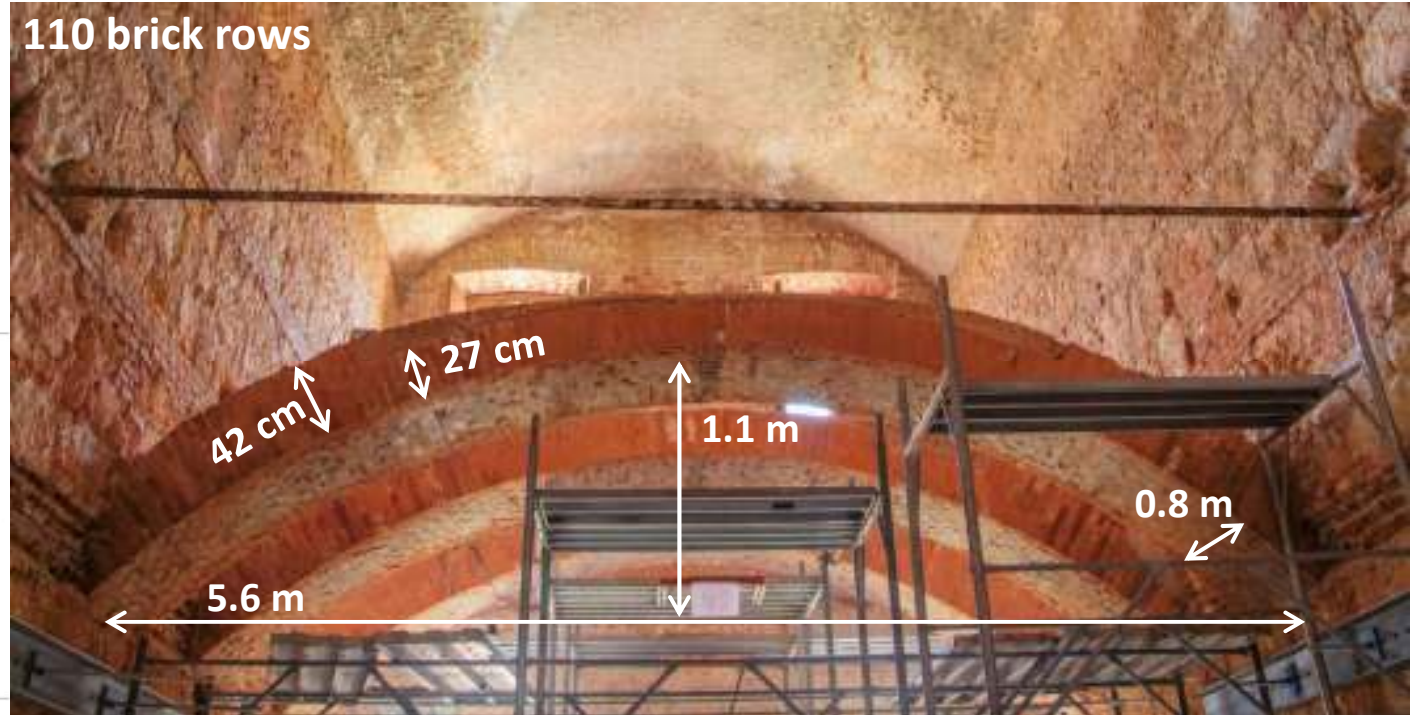
110 brick rows

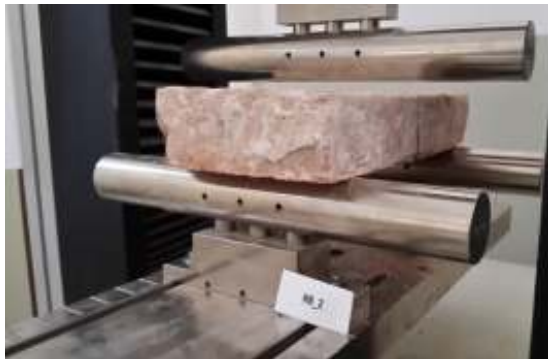
Flexural tension

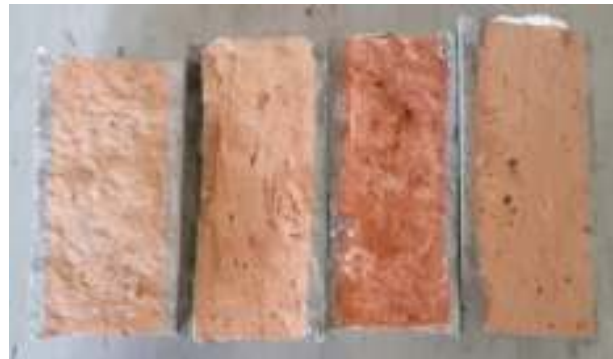
Splitting tension

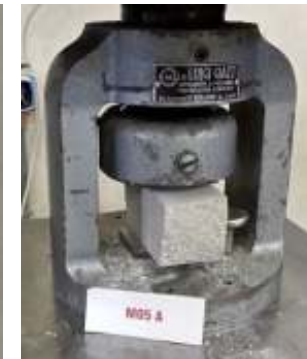
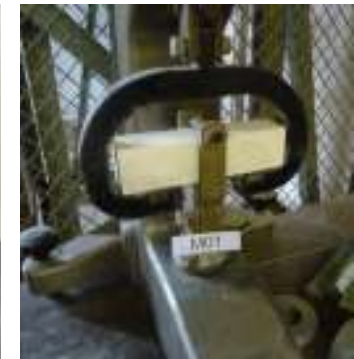
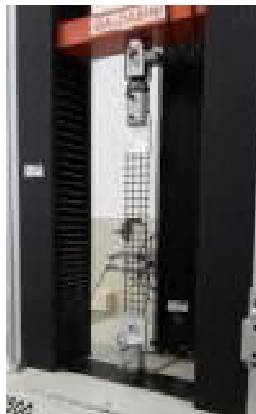
Compressive test Flexural tension

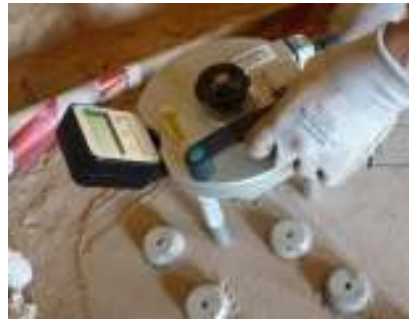
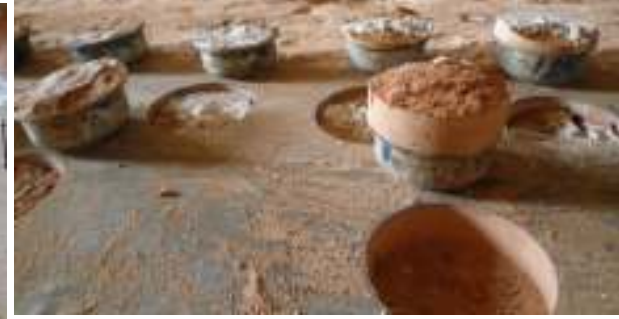
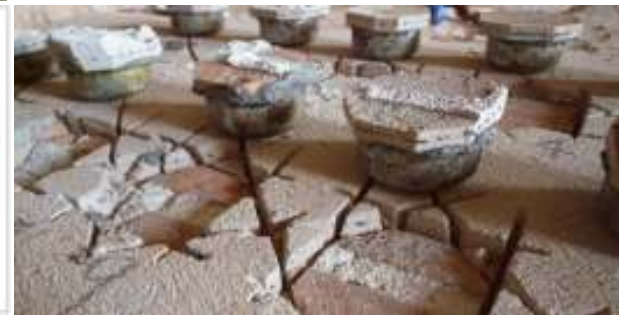
Orthogonal bond

- *Useful to survey the system quality of application*
- *Does not provide information on the system capacity*
- *Especially in case of FRCC the main failure is not 'A' (failure on the substrate)*

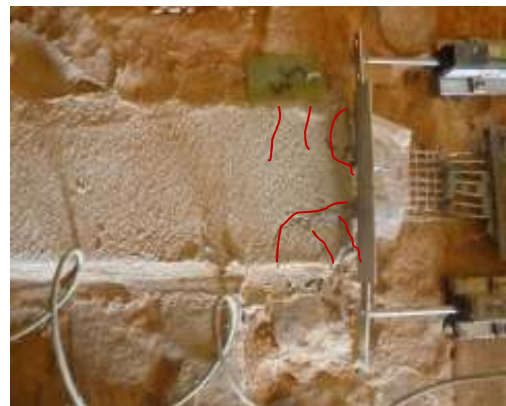
Shear tests

- *Shear test on site helps to characterize the real response of the system*
- *Useful to assess the anchorage length*
- *No suitable information about the bond constitutive law*

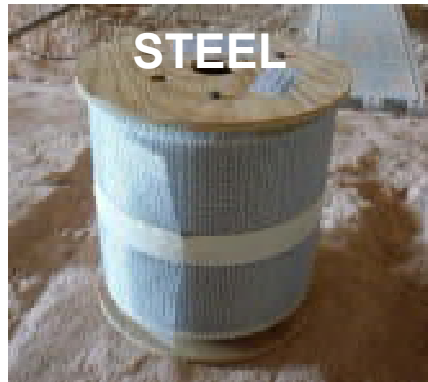
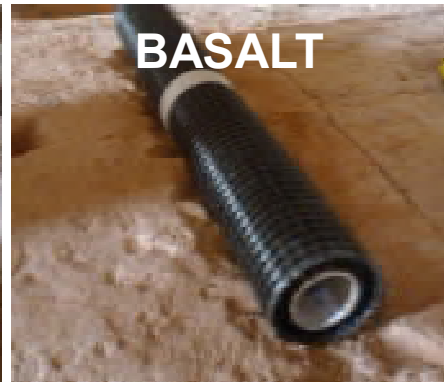
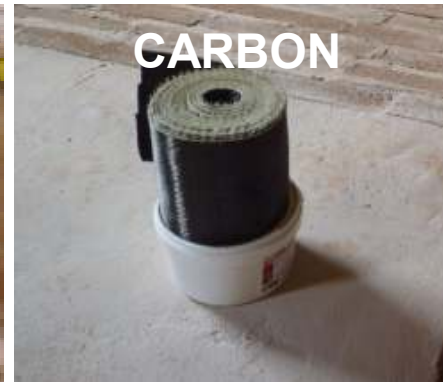
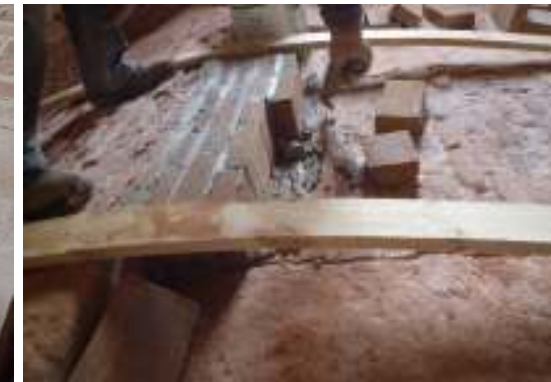
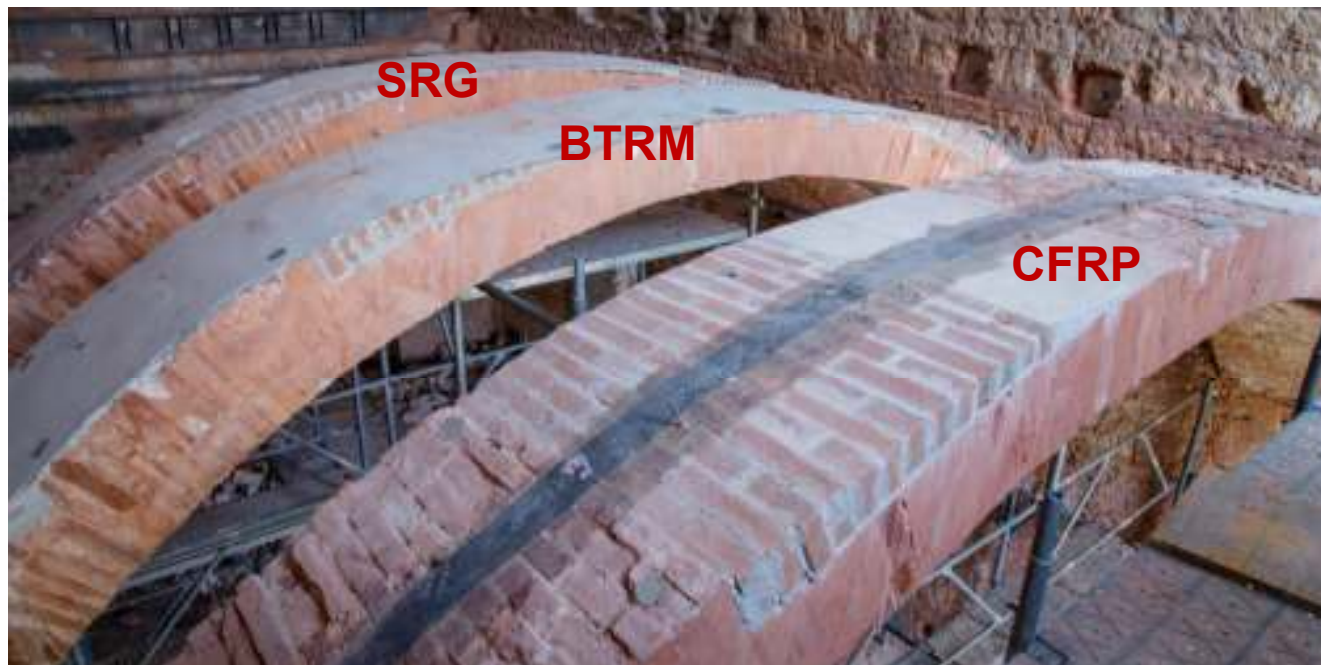
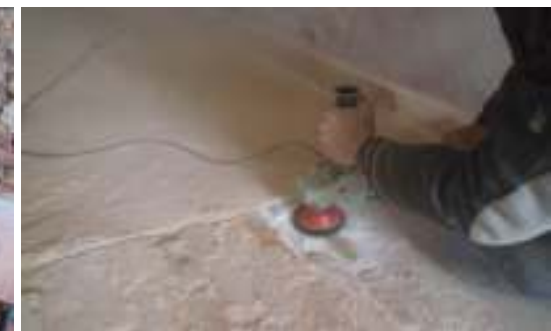
TEST ON VAULTS- IN SITU

Fibres designed according the ultimate strength

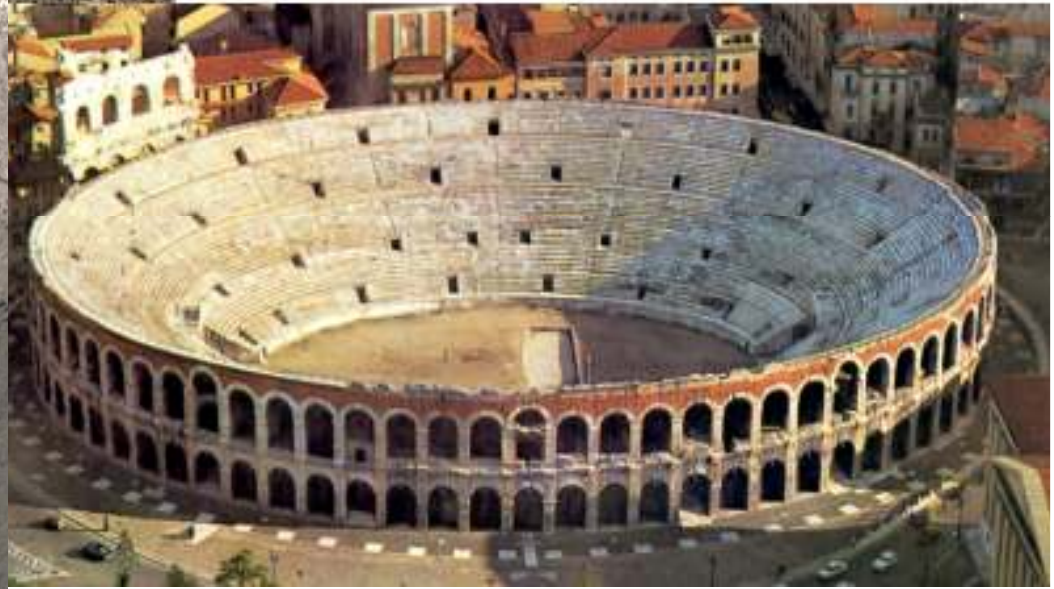
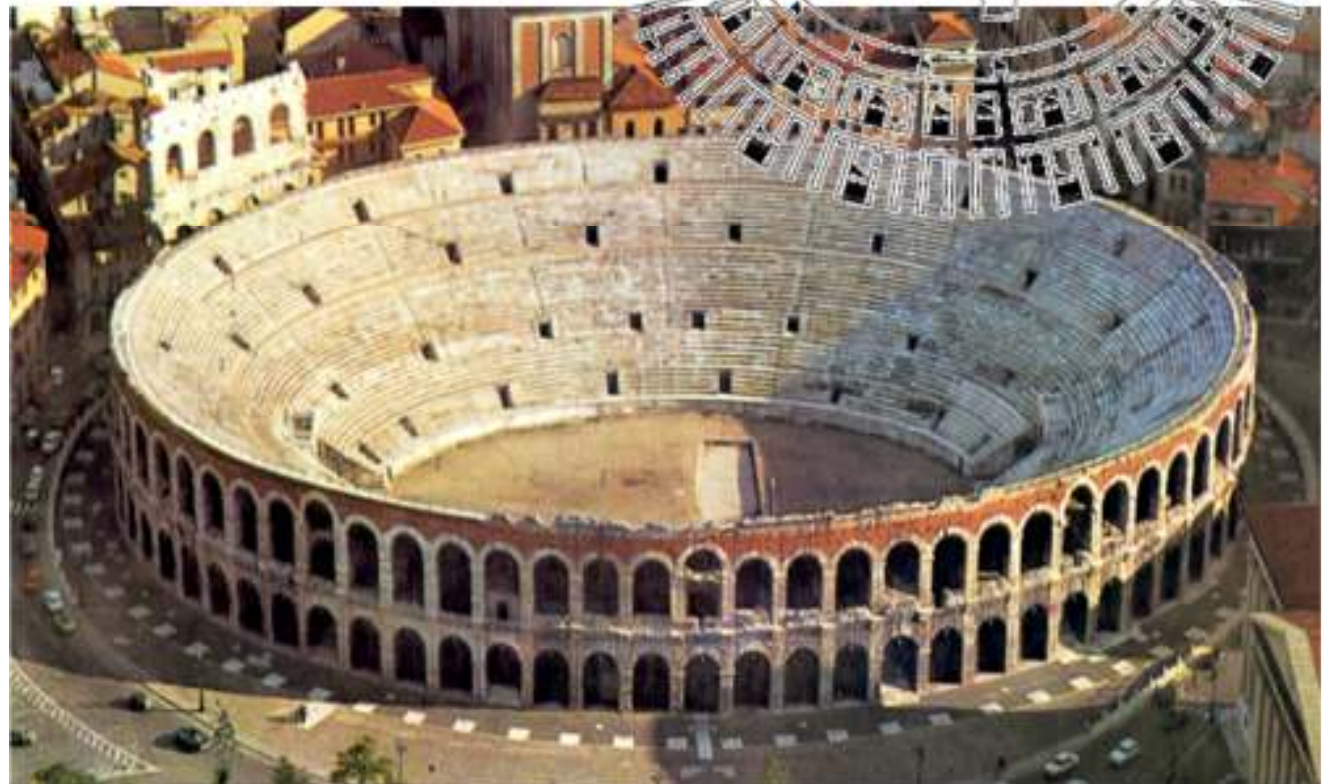
The Arena dimensions are about 138 x 109 meters on the outside while the inner elliptic pit is about 44 x 73 meters. There are 45 tiers of steps wherein the opera audience can sit. The building, as other structures of its kind, is composed by a symmetrical arrangement of radial masonry walls separating the the 72 "Arcovoli" (accesses to the courtyard) and three concentric distributive elliptical galleries. Main employed materials are the "opus caementicium" that is to say the roman concrete, and a massive squared stone masonry block masonry.

The **monument was subjected** to several natural and man induced actions, like the **flooding** of 589 AD, the **earthquakes** of 1116 and 1117, leading to the almost complete collapse of the outer ring of the Arena, the collapse of 5 arcades on Bra square in 1579, and the continuative **stealing of stones** and material for re use in other constructions, until being treated like an “historical” monument, with archeological excavations, starting from the XVIII century.

XX century structural interventions and induced damages are documented more in detail: in 1939, both the need of intervening on the external “Ala” for manifest tilting and the necessity of protecting the same structural portion from the possible damages induced by the II w.w. consequences, rendered necessary the construction of massive buttresses , removed after the end of the war by an intervention of post tensioned tendons vertically positioned within the pillars (1956).

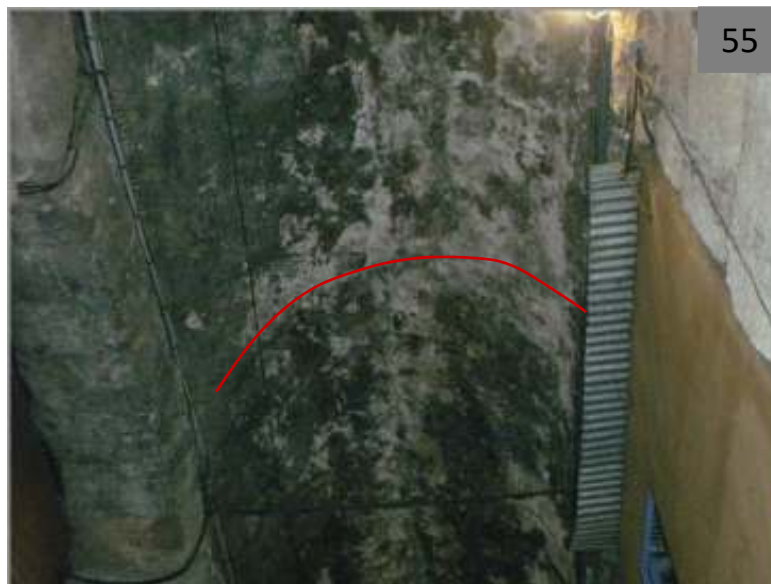
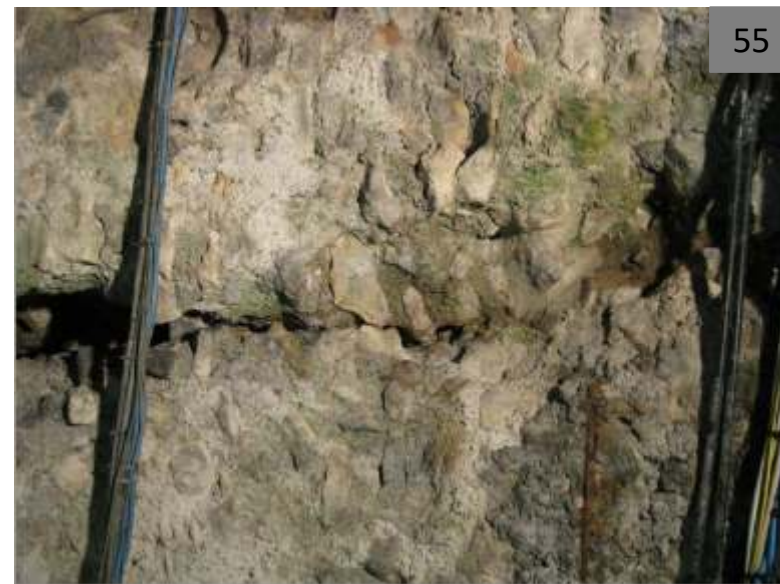
Gate 55

DAMAGE PATTERN SURVEY

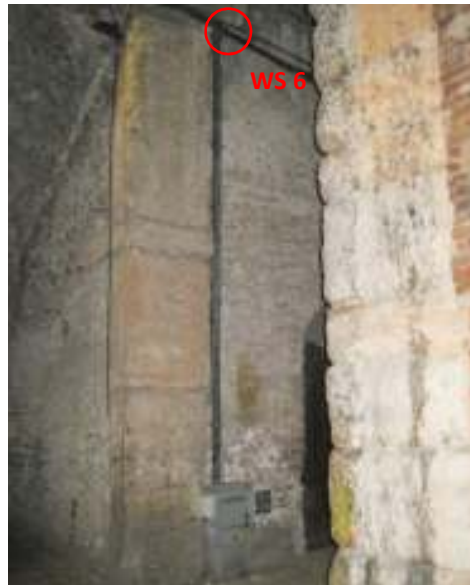
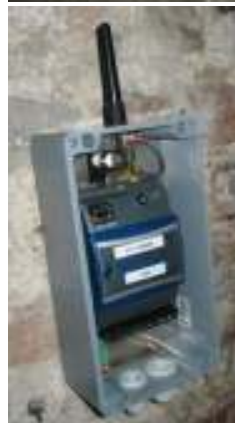
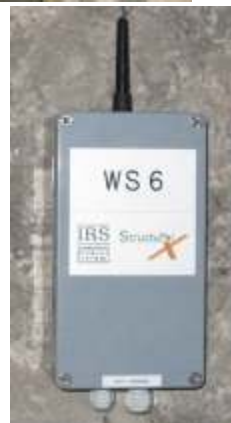
STRUCTURAL HEALTH MONITORING

Static sensors

Wireless Node	Corresponding gate nr
WS 1	66
WS 2	17
WS 3	58
WS 4	25
WS 5	7
WS 6	35

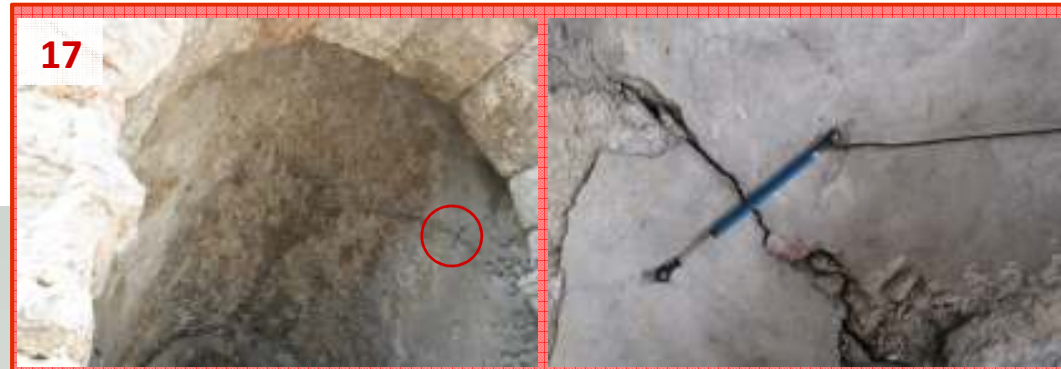
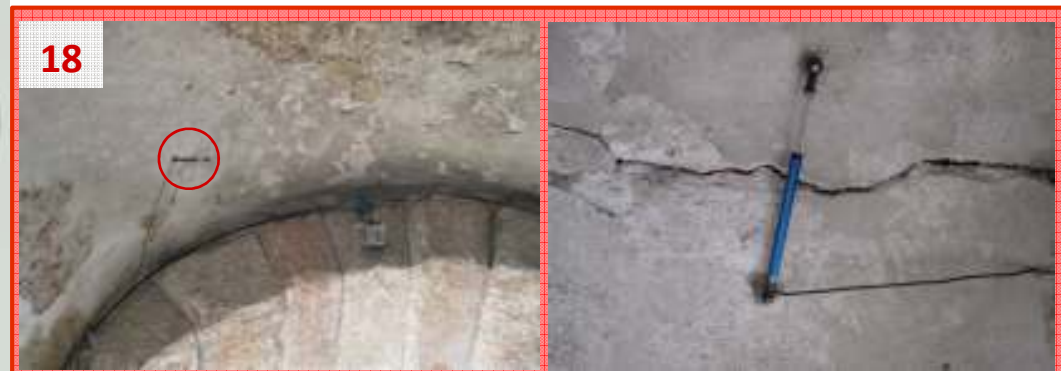
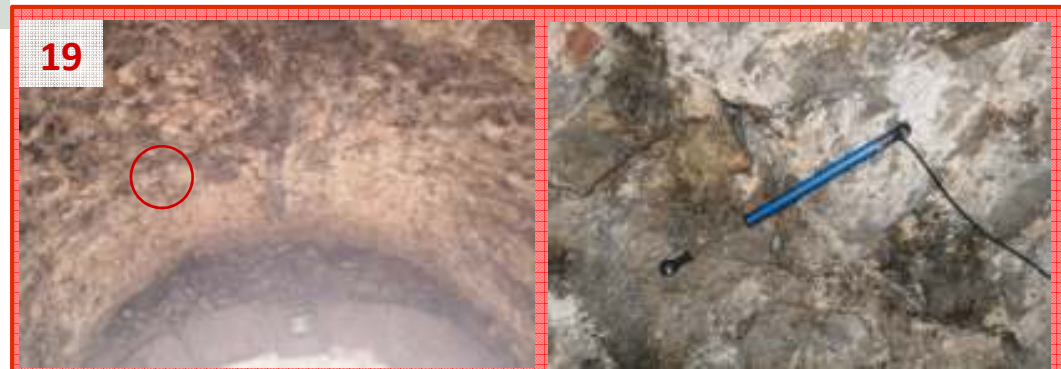
STRUCTURAL HEALTH MONITORING

Static sensors

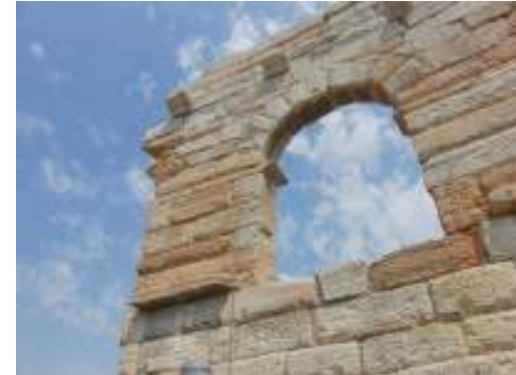
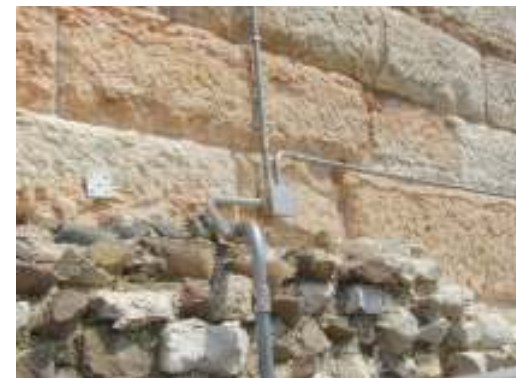
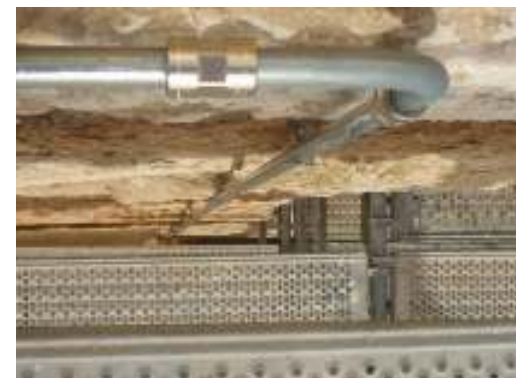
SHM SYSTEM - Dynamic sensors

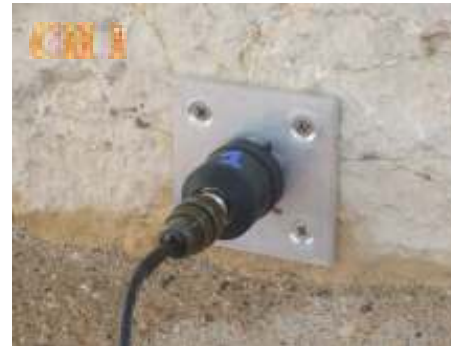
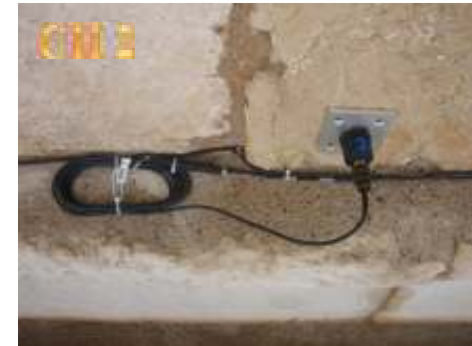
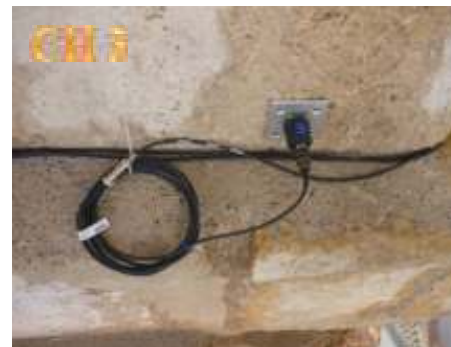
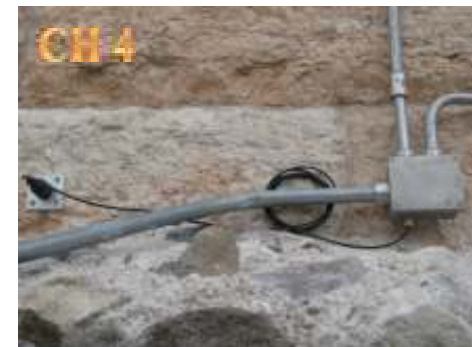
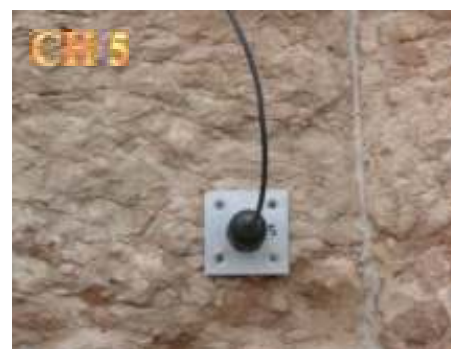
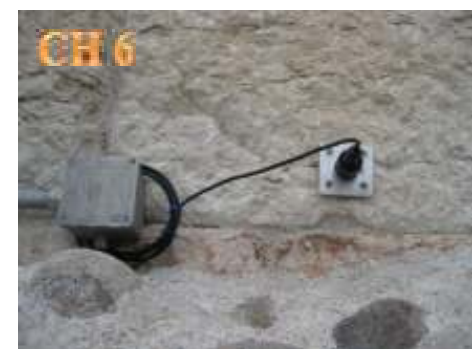
SHM SYSTEM - Dynamic sensors

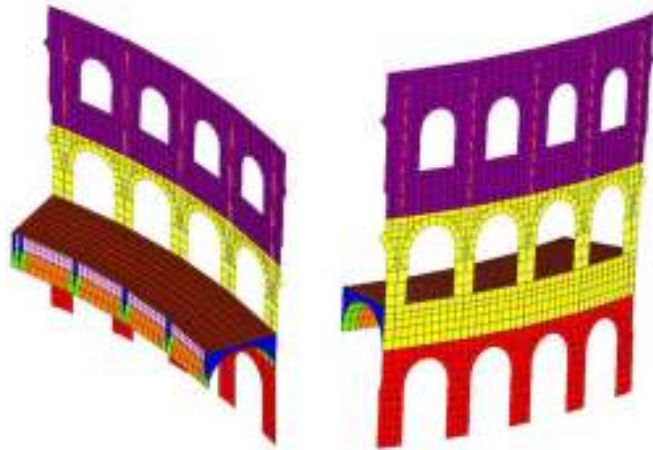
FE MODEL OF THE ARENA'S WING

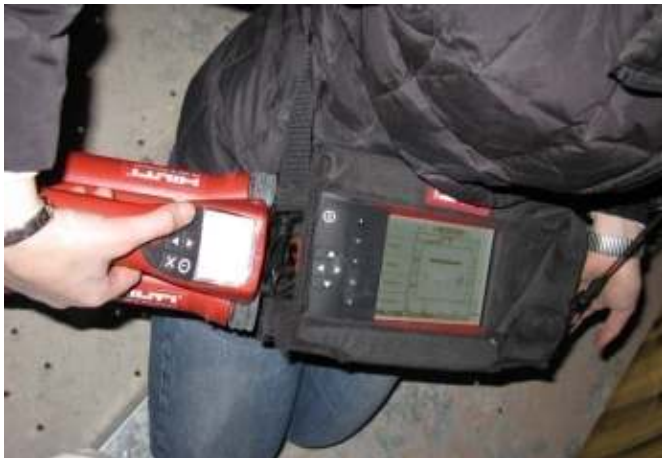
DETAIL CHARACTERIZATION

- local scarifications
- survey of reinforcement bars by direct inspection
- survey of reinforcement bars by NDT test:
 - Ground Penetration Radar
 - Ferroskan - analysis of magnetic fields

Ferroskan

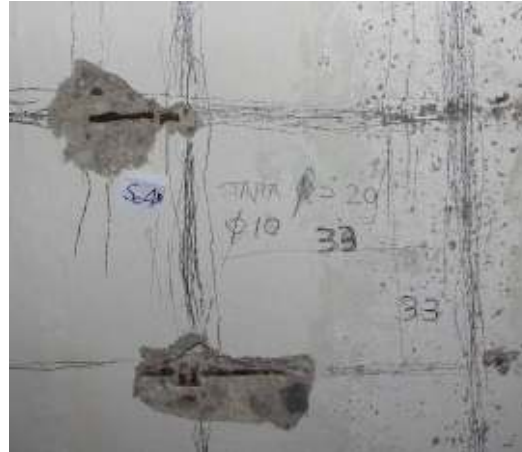
Local scarifications

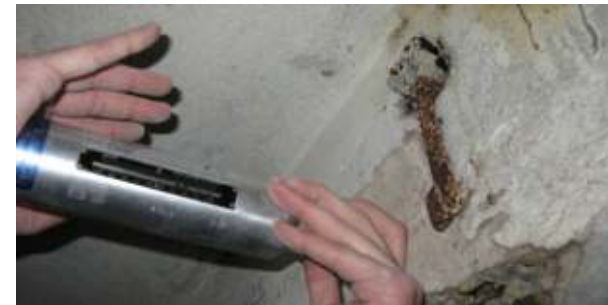
Sclerometer

- carbonation depth measurement test
- tensile test of reinforcement bars
- sampling of reinforcement bars
- sampling of concrete corings
- Schmidt rebound hammer test
- Ultrasonic tests and combination with Rebound (SONREB)

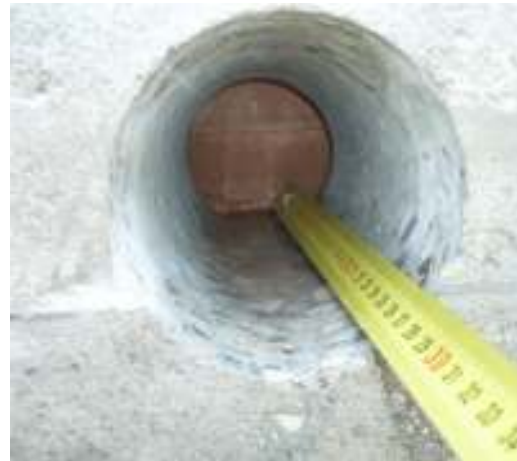
Coring and tests

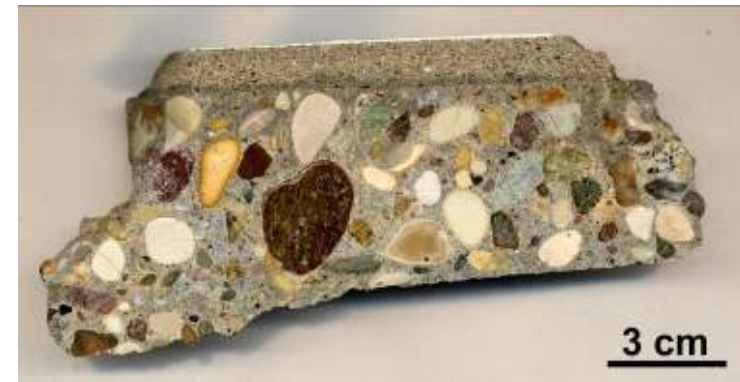
Compositional visual analysis

- aggregate characterisation
- porosity study
- compositional ratio identification
- alteration phenomena identification

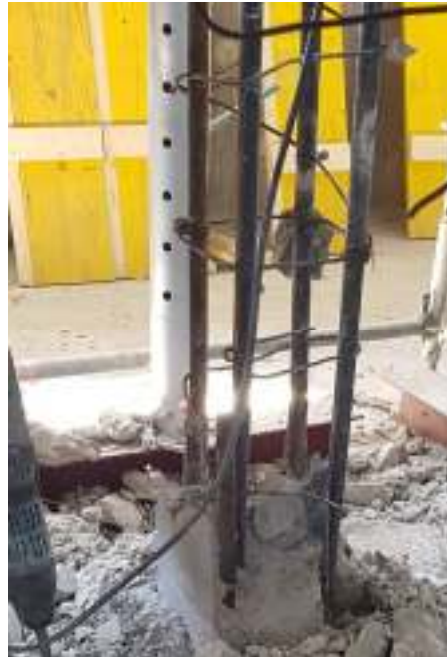
Typical steel reinforcement in columns

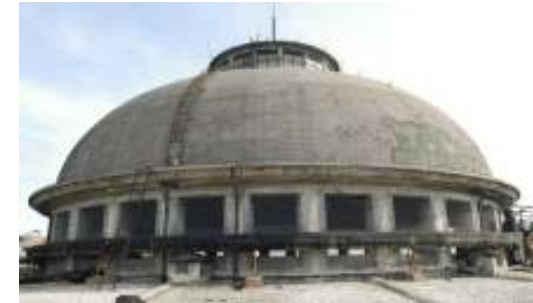
General deterioration of the rc dome.

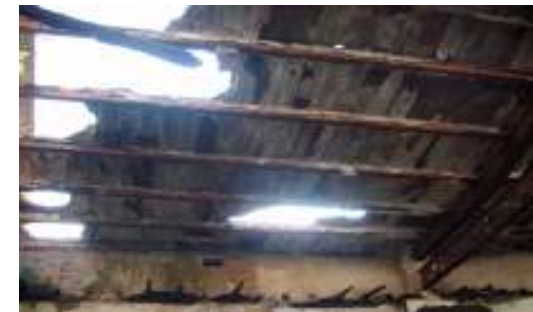
Roof degradation on the external ring

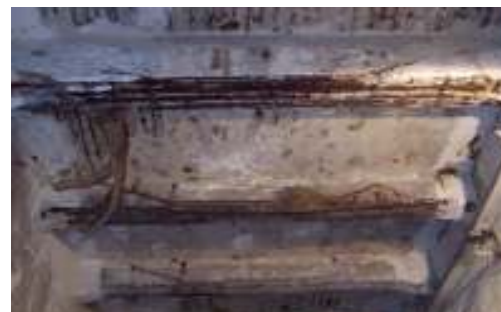
Degradation of the slab and beams of the first floor at the access tunnels

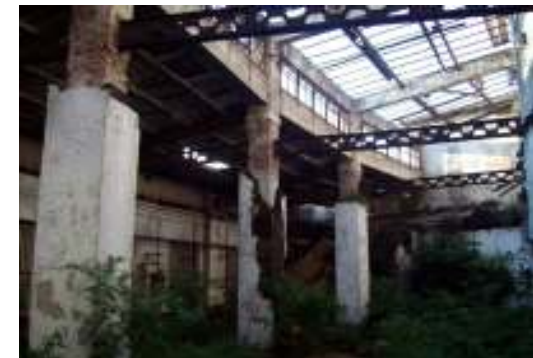
Steel roof degradation on the external ring

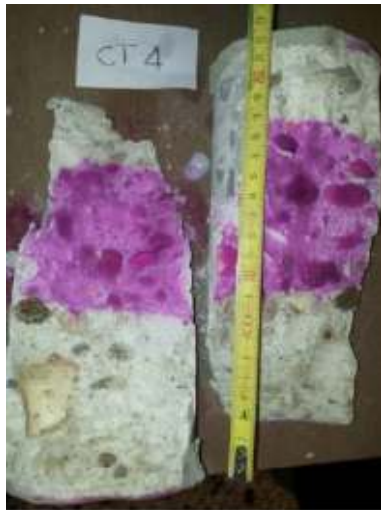
Tests on R.C. structures

- Diffuses carbonatation tests
- N.10 Compression tests on cores
- N. 4 tensile tests on rebars
- N. 28 direct sonic tests before and after consolidation
- N. 3 Brinell tests

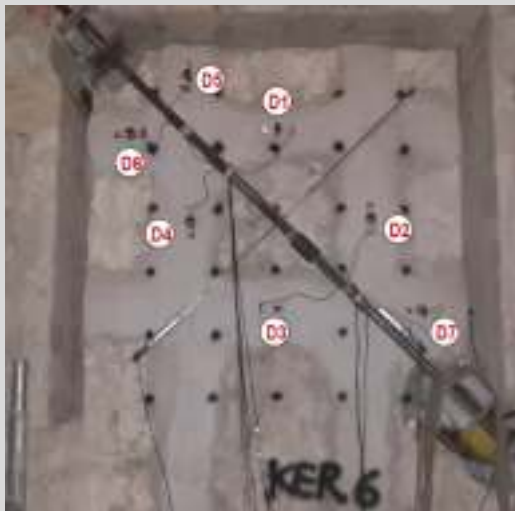
Tests on masonry

- N.6 Video endoscopy
- N.2 Single flat jack and 4 Double flat jacks
- N. 5 direct sonic tests
- N. 8 direct sonic tests before and after consolidation
- N. 8 Diagonal compression test
